Russell Island Bridge Inspections

Inspected By: Mike Cieslinski

Inspection Date: April 12, 2023

Calculations By: Michael J. Clark, PE

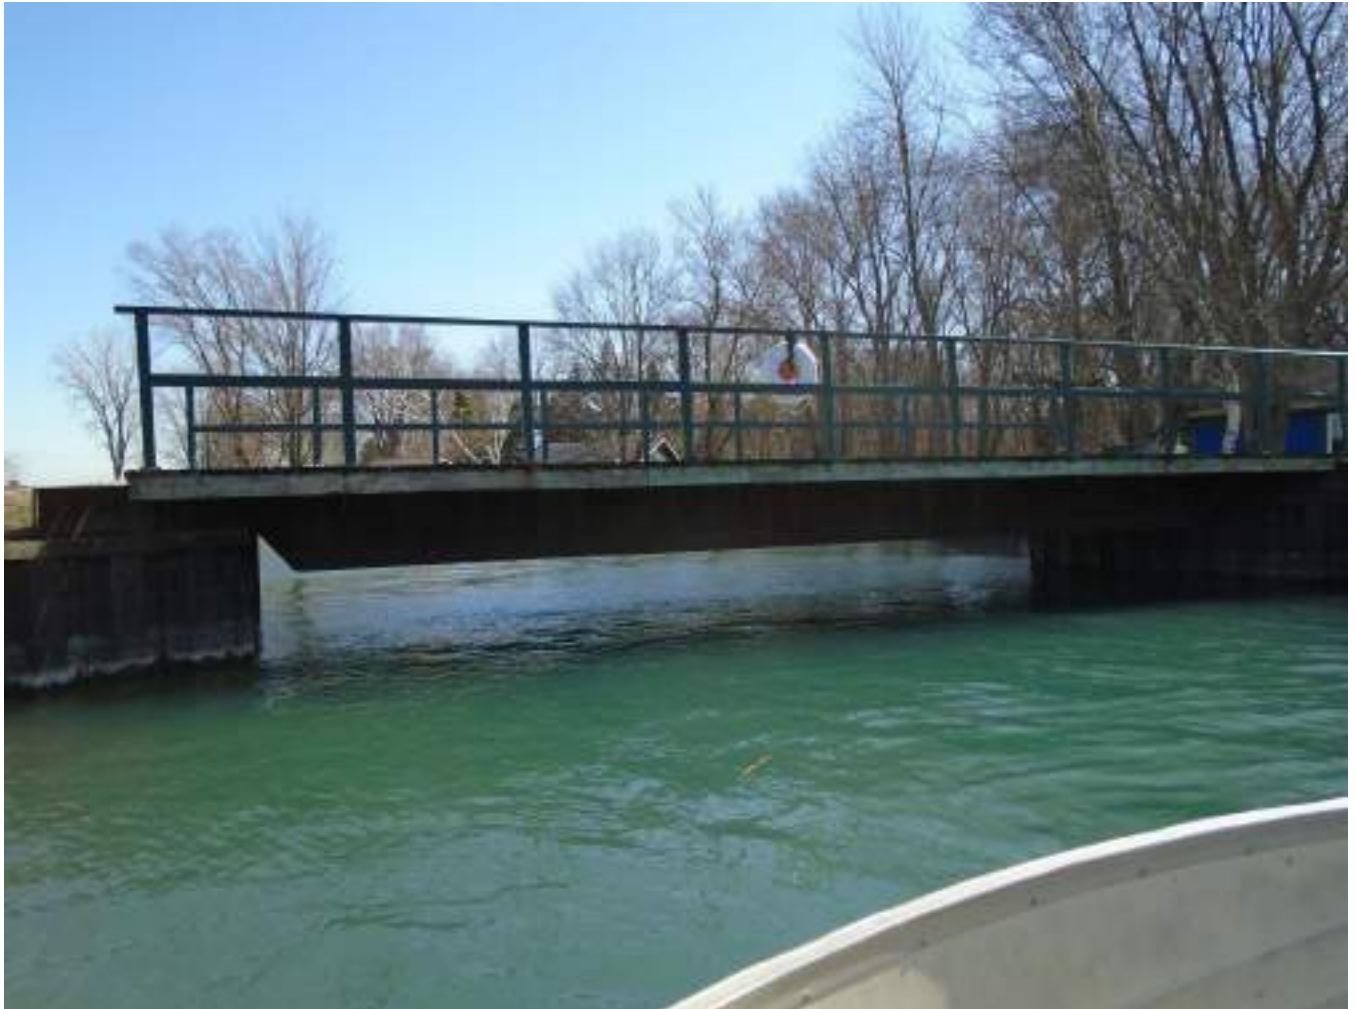
Seminole Bridge Picture #1

South elevation

This view shows the view looking north from the south side of bridge.

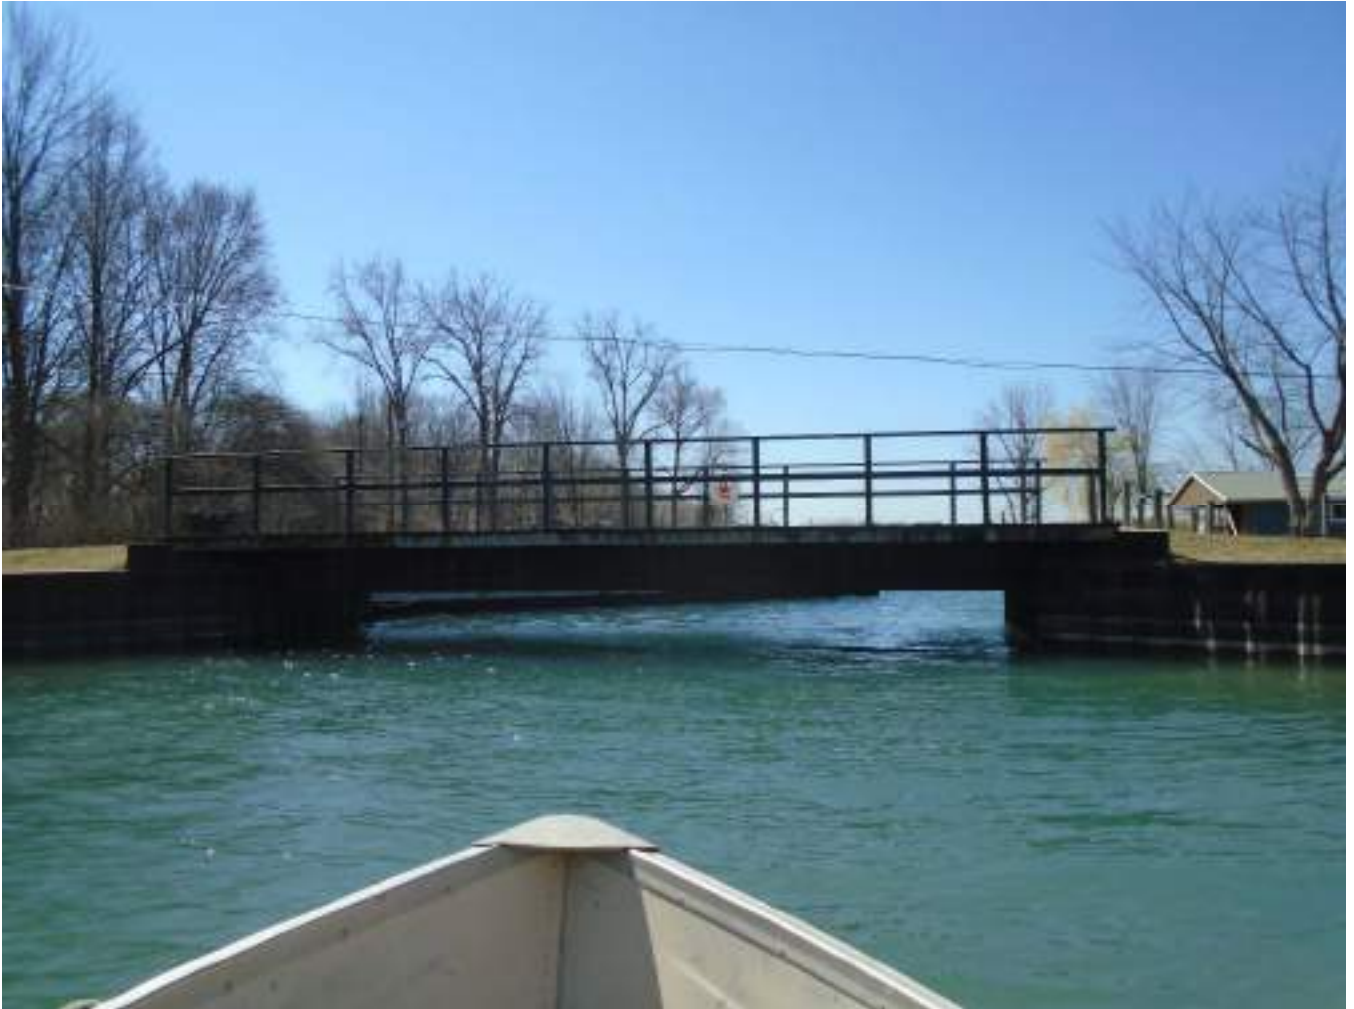
Seminole Bridge Picture #2

North elevation

This view shows the view looking south from the north side of bridge.

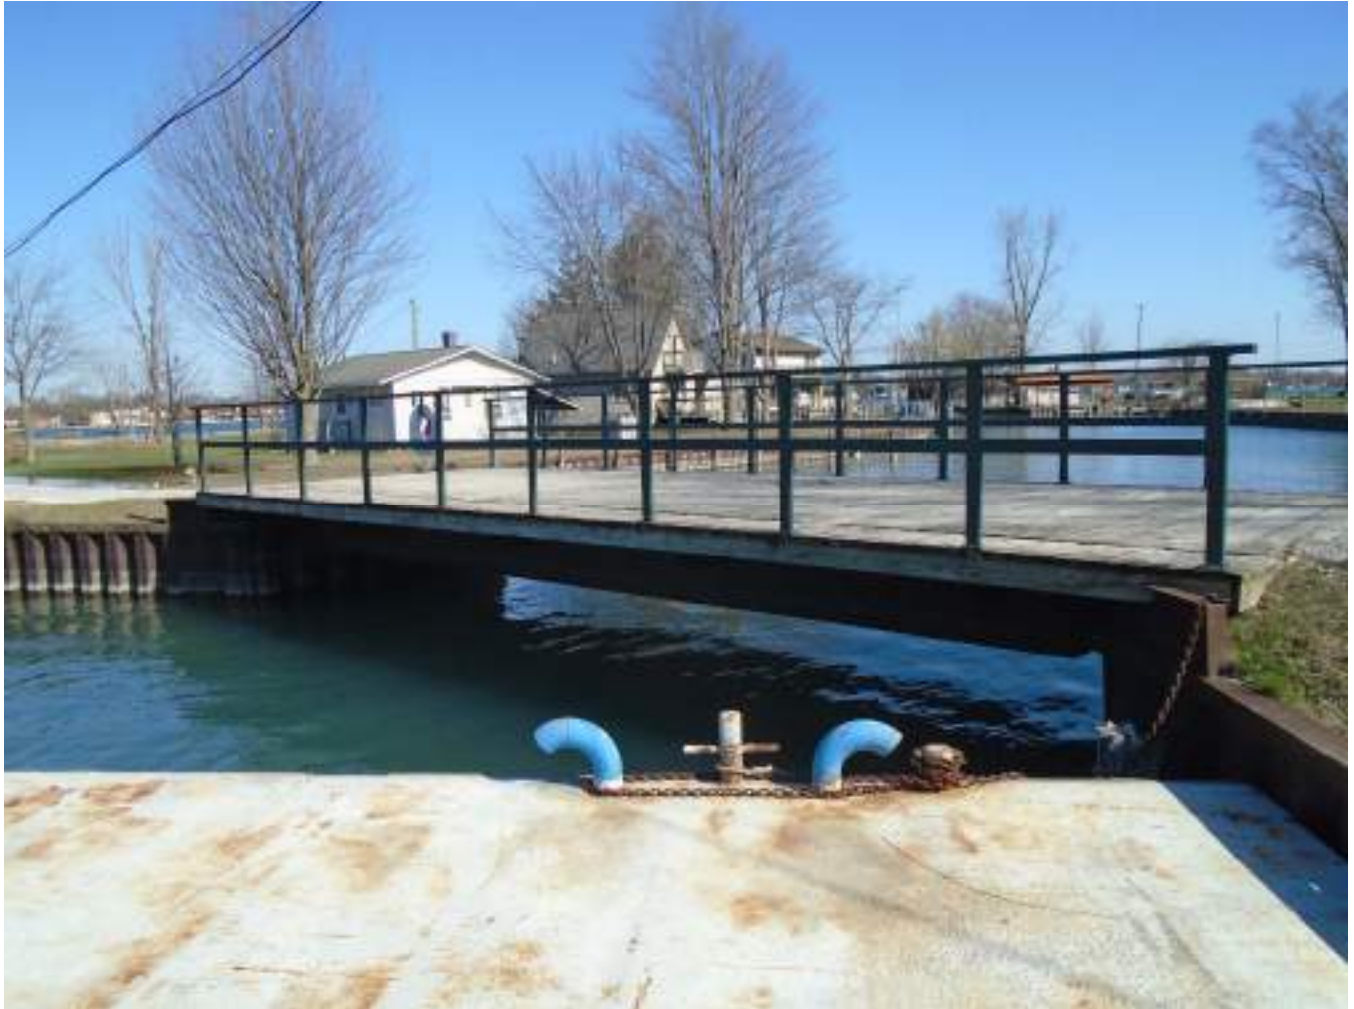
Seminole Bridge Picture #3

Looking NW elevation

This view shows the steel sheet piling lining the channel and running under the bridge. The bridge superstructure is resting on the steel sheet piling which is acting as the substructure (abutment). It is assumed that steel sheet piling is built using standard methods which would include periodic tie-backs fastened to deadman piles and an embedment of at least 1/3 the total pile length. Notice that the bridge deck has been widened (+/- 24" widening each side).

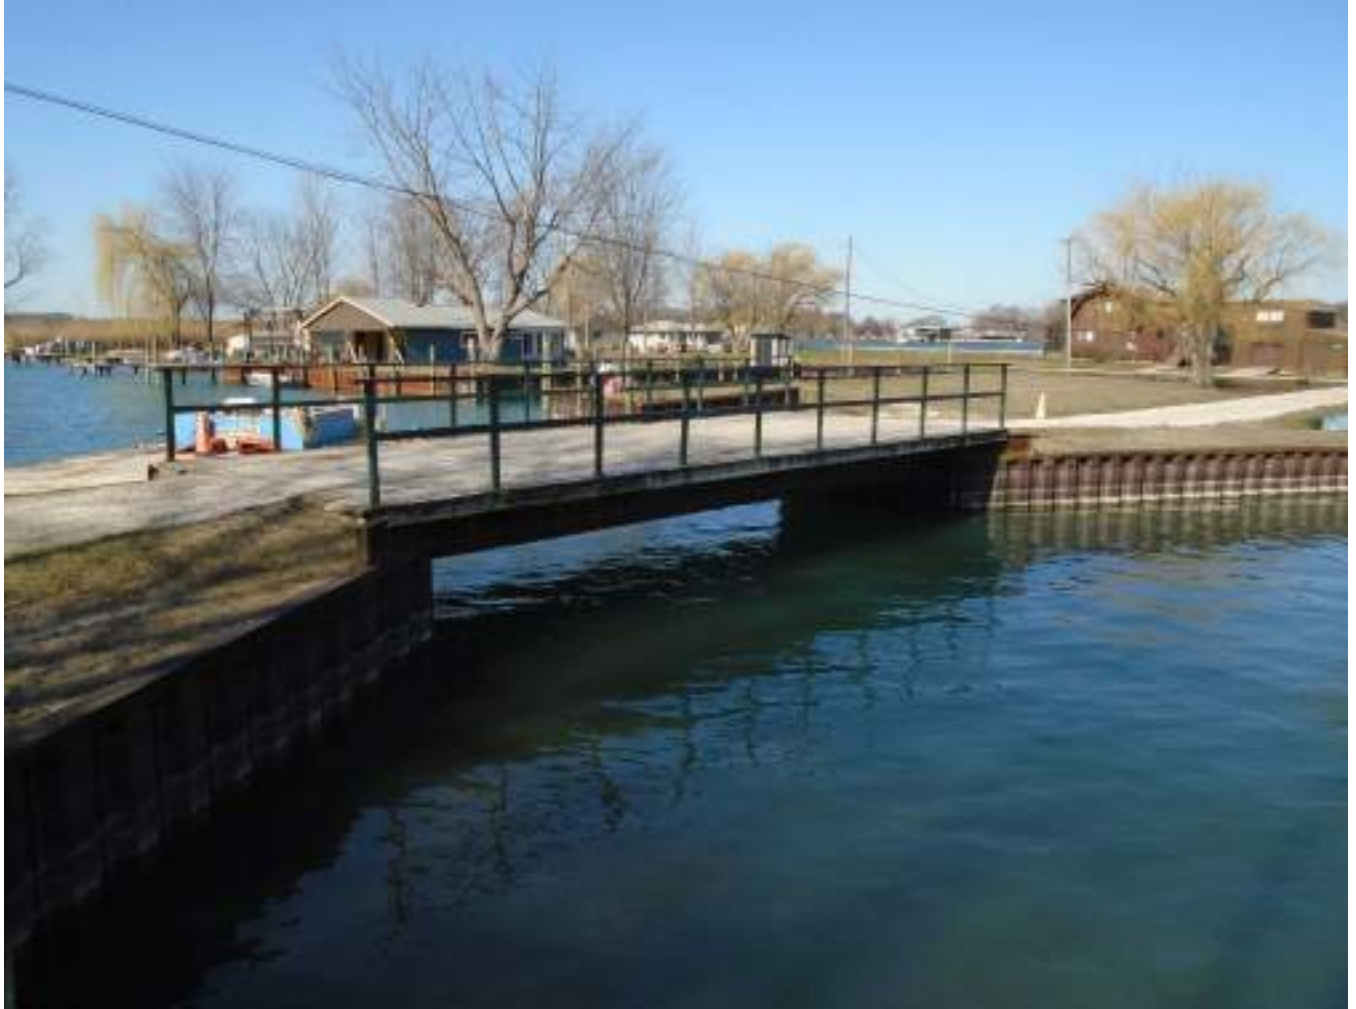
Seminole Bridge Picture #4

Looking SW elevation

View from the other side of the bridge shows the steel sheet piling lining the channel as it connects to the bridge abutments. All steel sheet piling is in very good condition in the area of the bridge. Again, notice that the bridge deck has been widened.

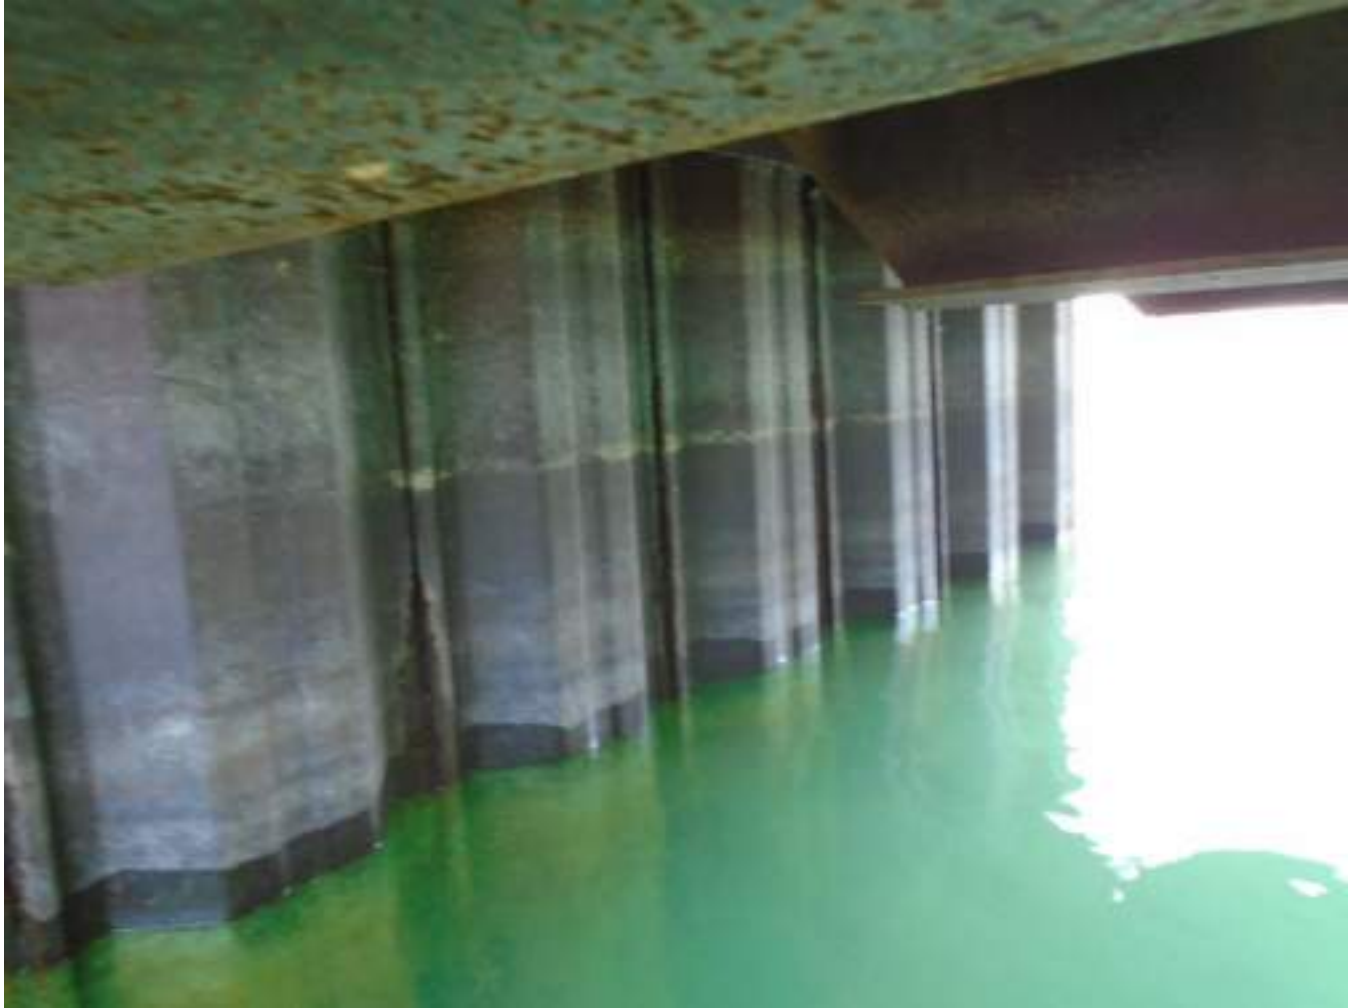
Seminole Bridge Picture #5

Looking NW at west abutment

This is a typical view of both abutments. All the beam ends are coped as shown. The beam ends sit on the wale cap of the steel sheet piling. All steel members are in good condition with only surface rusting.

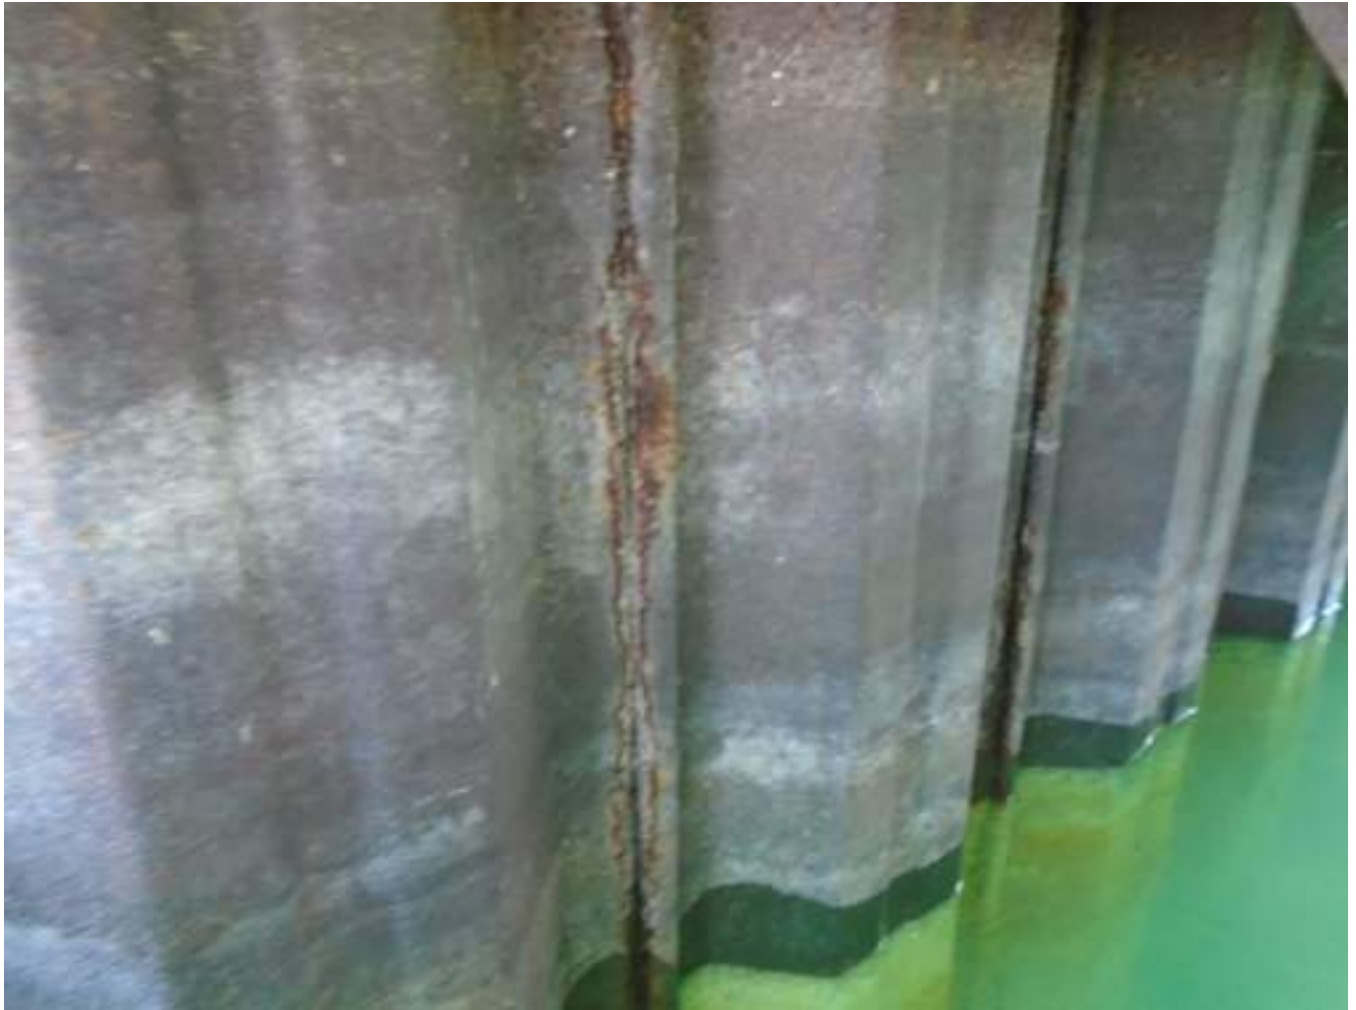
Seminole Bridge Picture #6

West sheeting/abutment joints

This is a typical view of both abutments. Minor rusting loss at sheeting joints typical of both abutments.

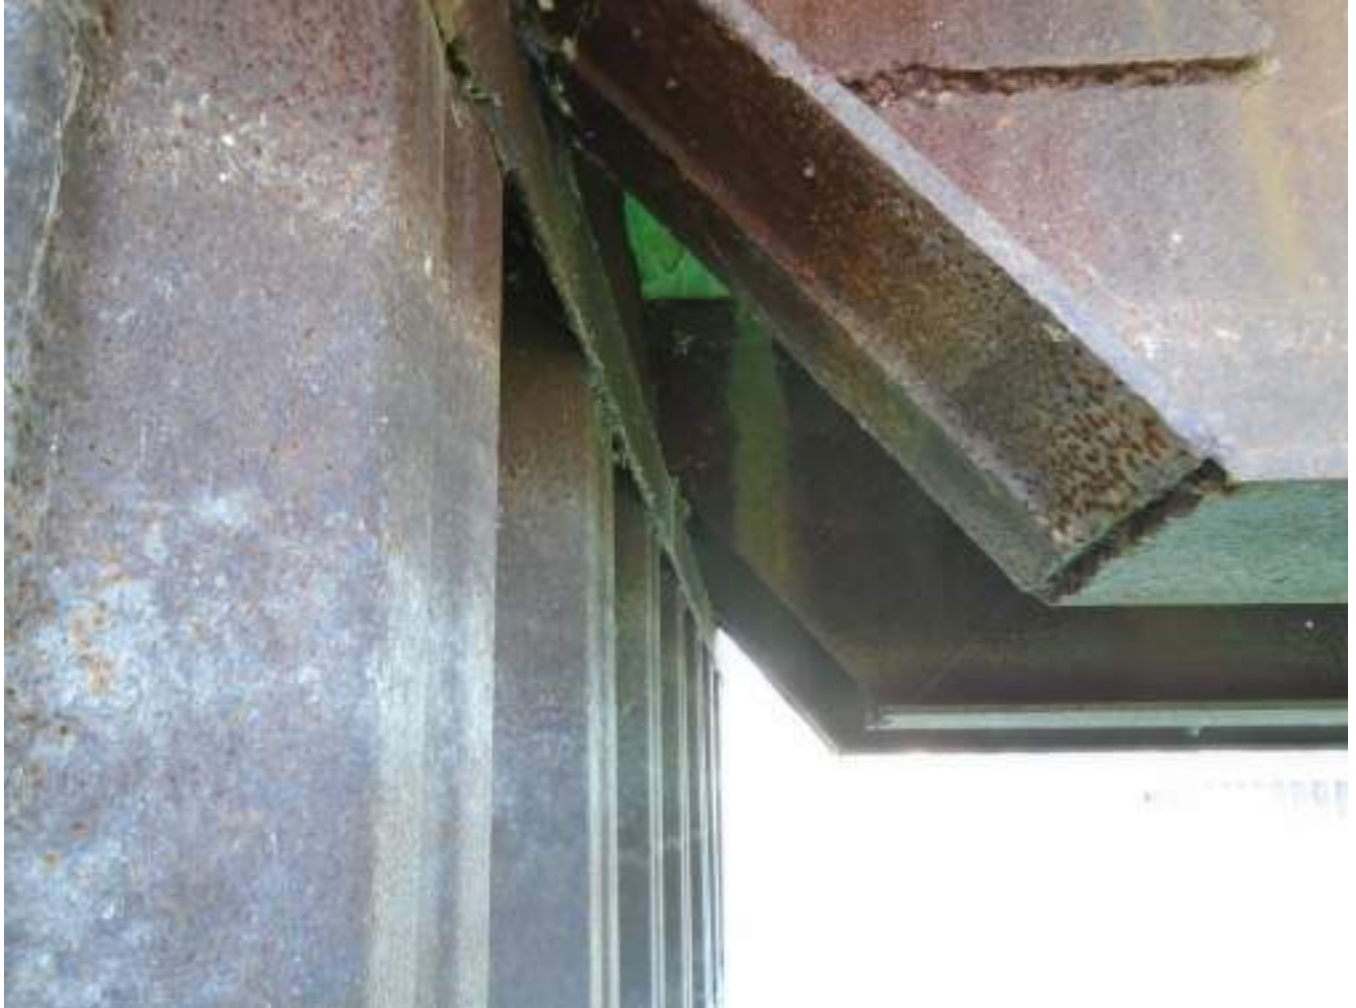
Seminole Bridge Picture #7

Looking north at west abutment

This is a typical view of both abutments. Again, notice all the beam ends are coped as shown. The beam ends sit on the wale cap of the steel sheet piling. All steel members are in very good condition with only surface rusting. There is no visible weld cracking or deterioration of all coping details.

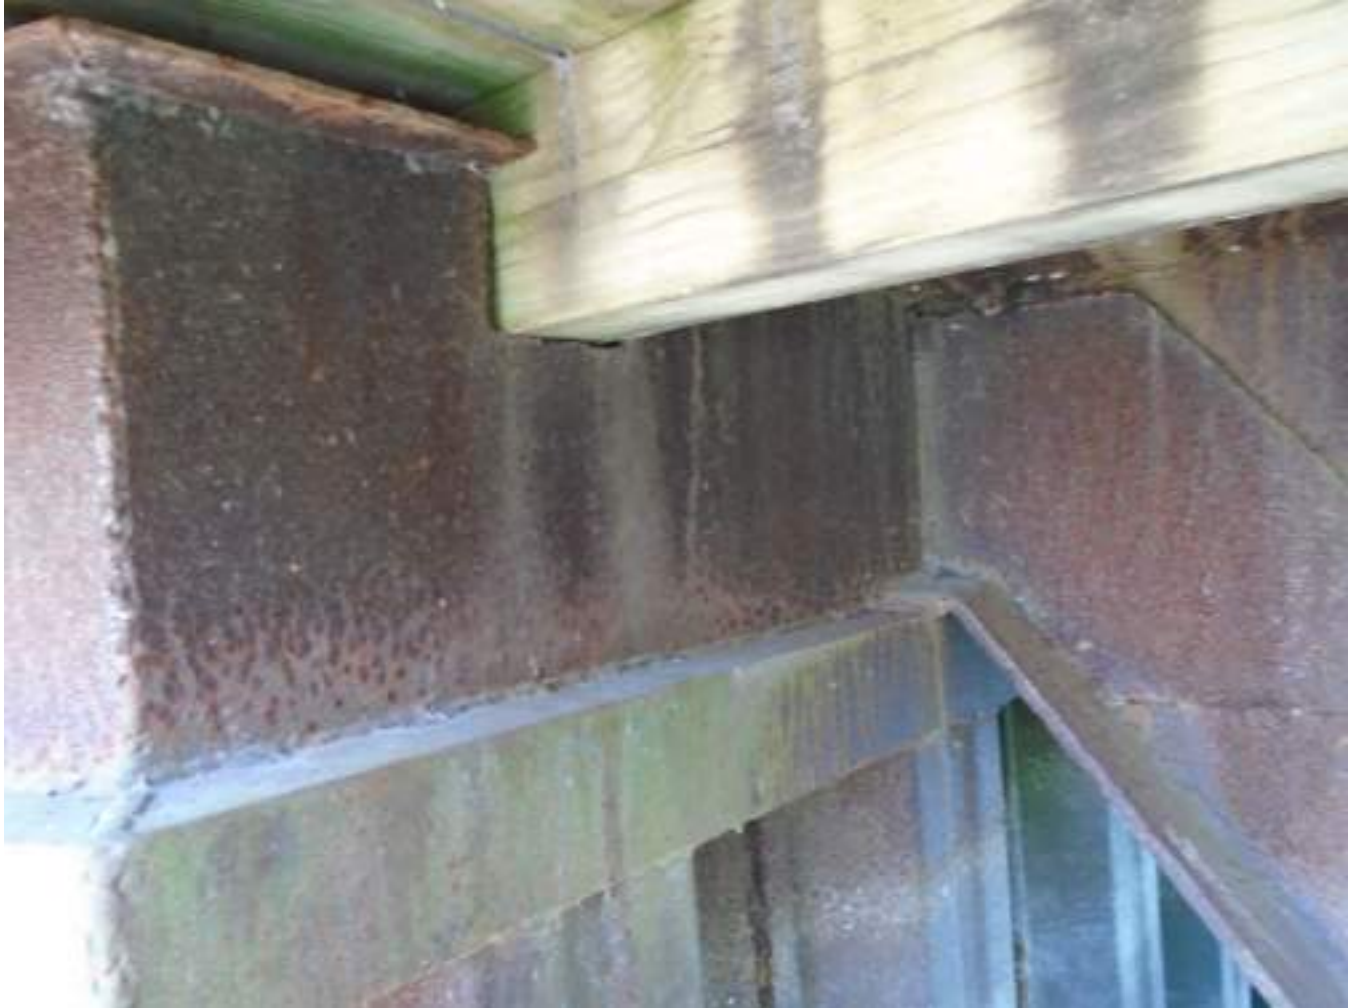
Seminole Bridge Picture #8

Looking NNE at East Beam End, Typical Exterior Cope Detail of Fascia Beams

Close-up view of beam end showing the coping and good condition of the steel. Also shows how the deck widening is cut into the existing seawall. Welds were sound and without cracks, typical of all welds.

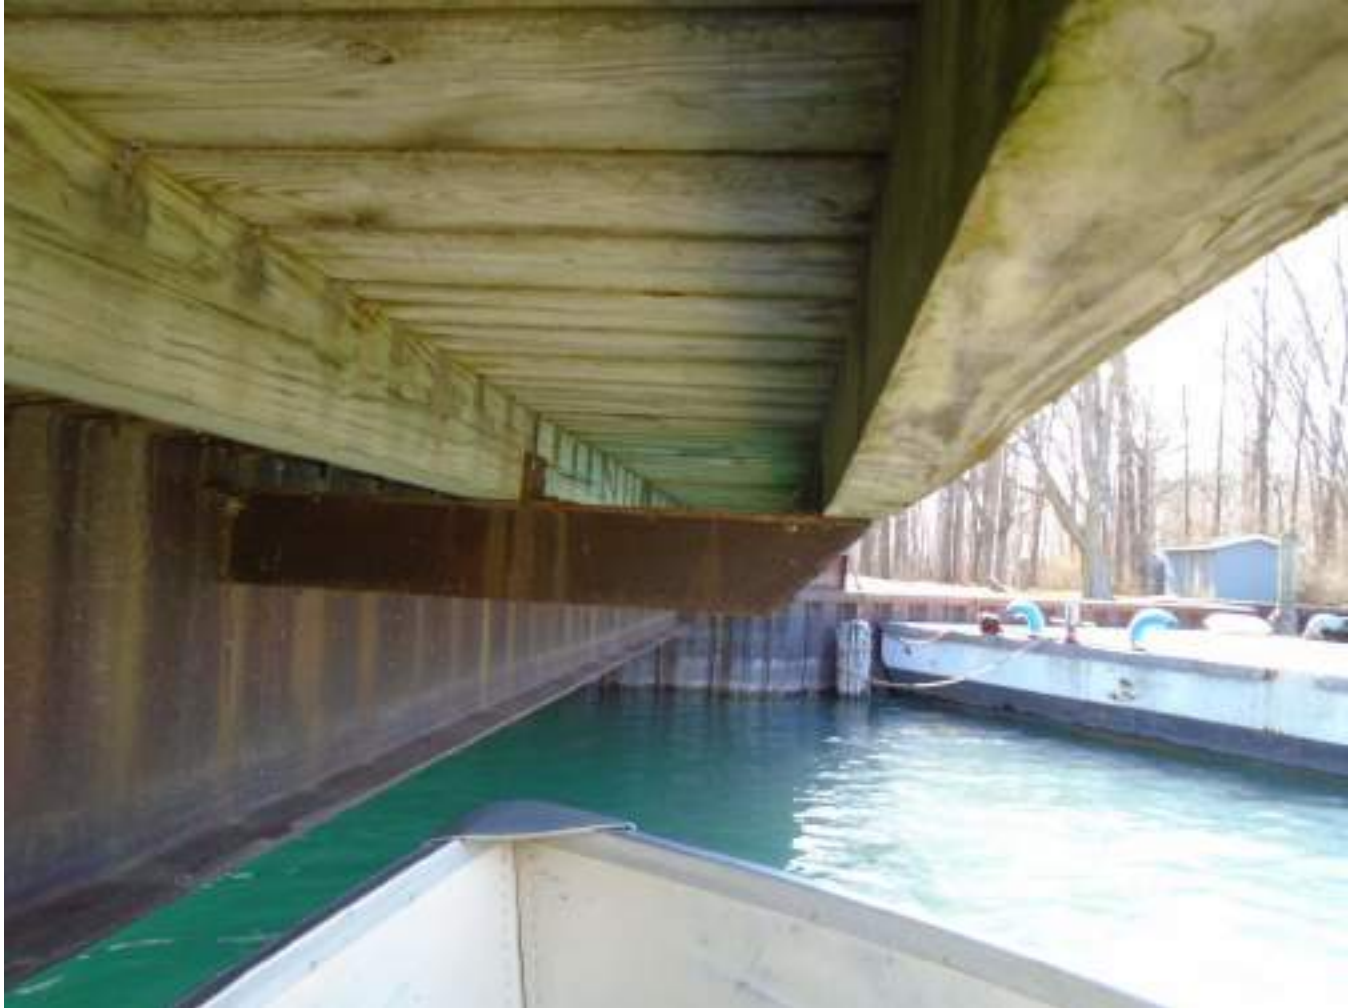
Seminole Bridge Picture #9

Looking east at south widening

This view of the widening shows wood and steel in good condition. Typical of the north widening as well. Visible 4"x 4" x ½" L-Bracket for widening of deck. L-Bracket is welded to main beam web.

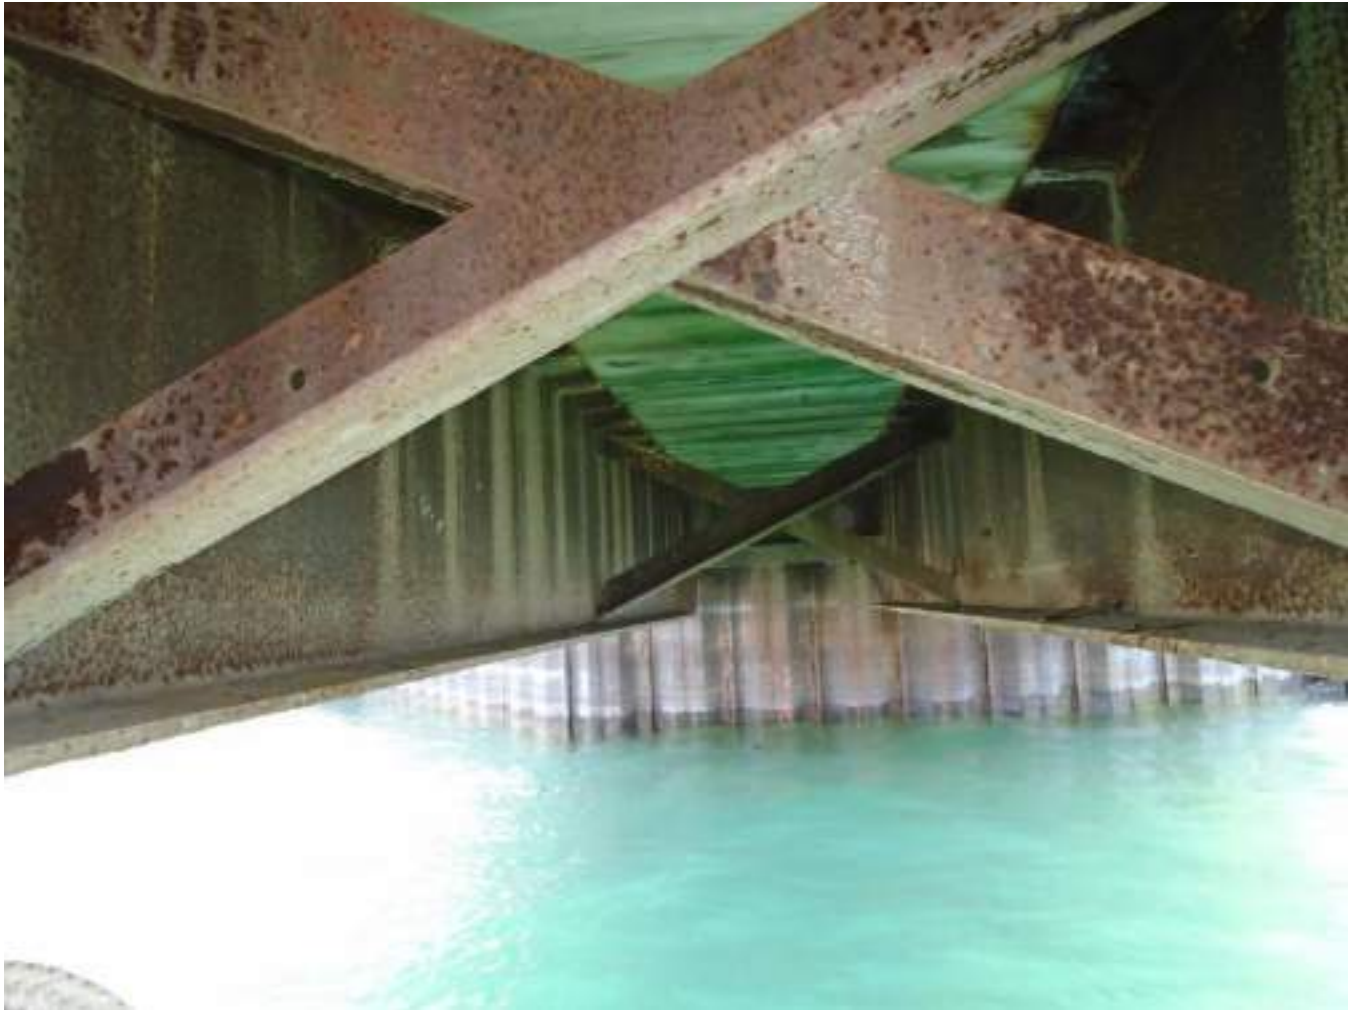
Seminole Bridge Picture #10

Looking East from West Abutment at Typical Cross Bracing Detail

Close-up view beam cross bracing between main stringers. Cross braces begin about 6 ½' from each end of bridge and are spaced about 8' apart (3 cross braces total for each stringer span). The cross braces are connected to the stringers with welds. No cracked welds were noted. Cross bracing built from 3 ½"x 4"x ½" L member.

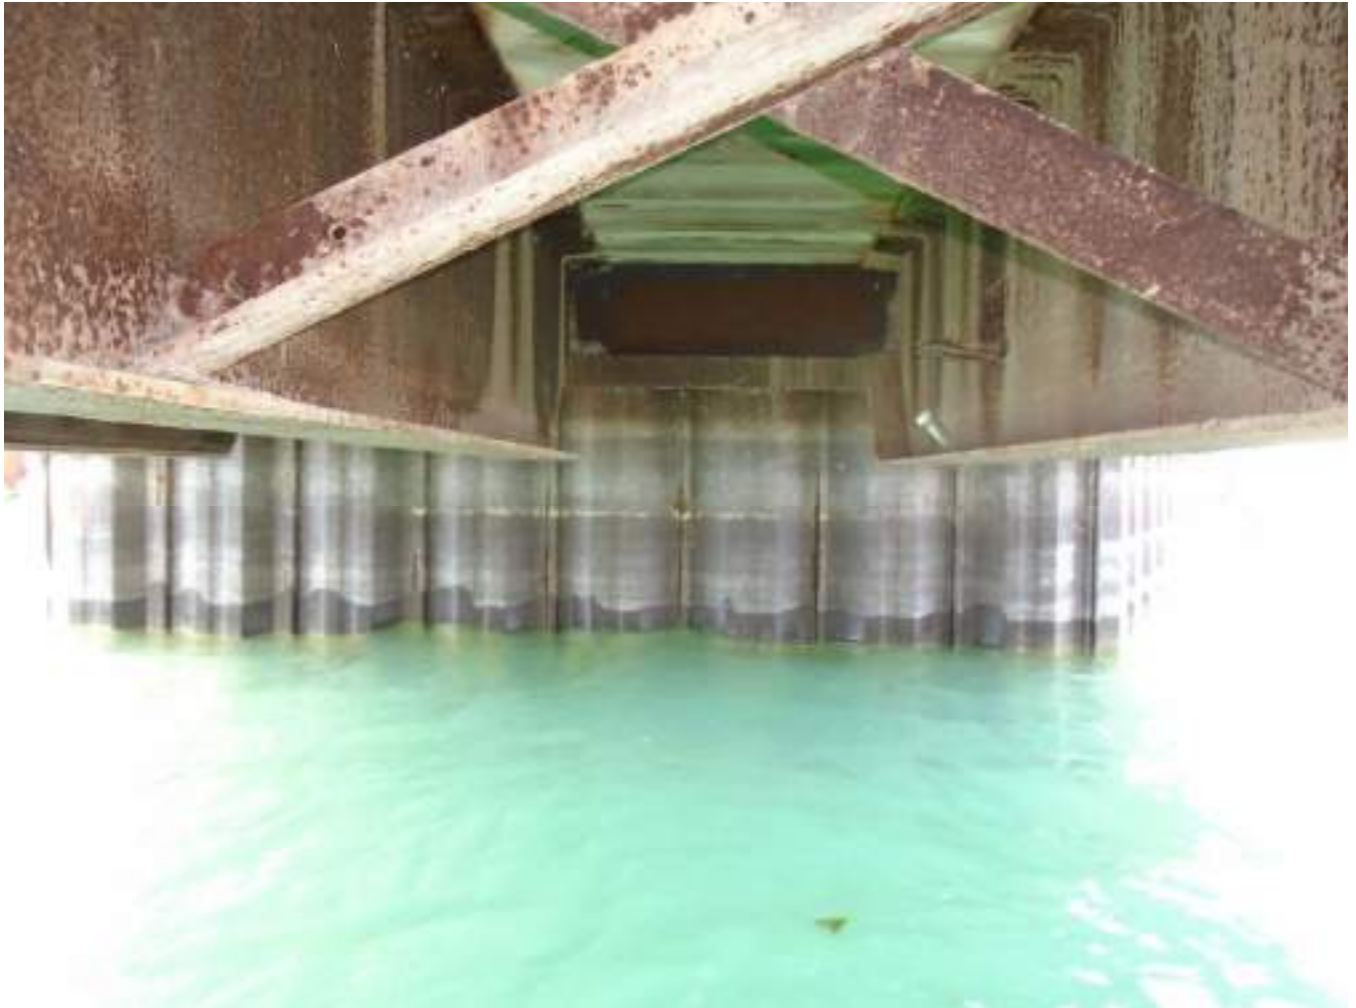
Seminole Bridge Picture #11

Looking West from East Abutment at Typical Cross Bracing Detail

Close-up view beam cross bracing between main stringers. No cracked welds were noted. Typical.

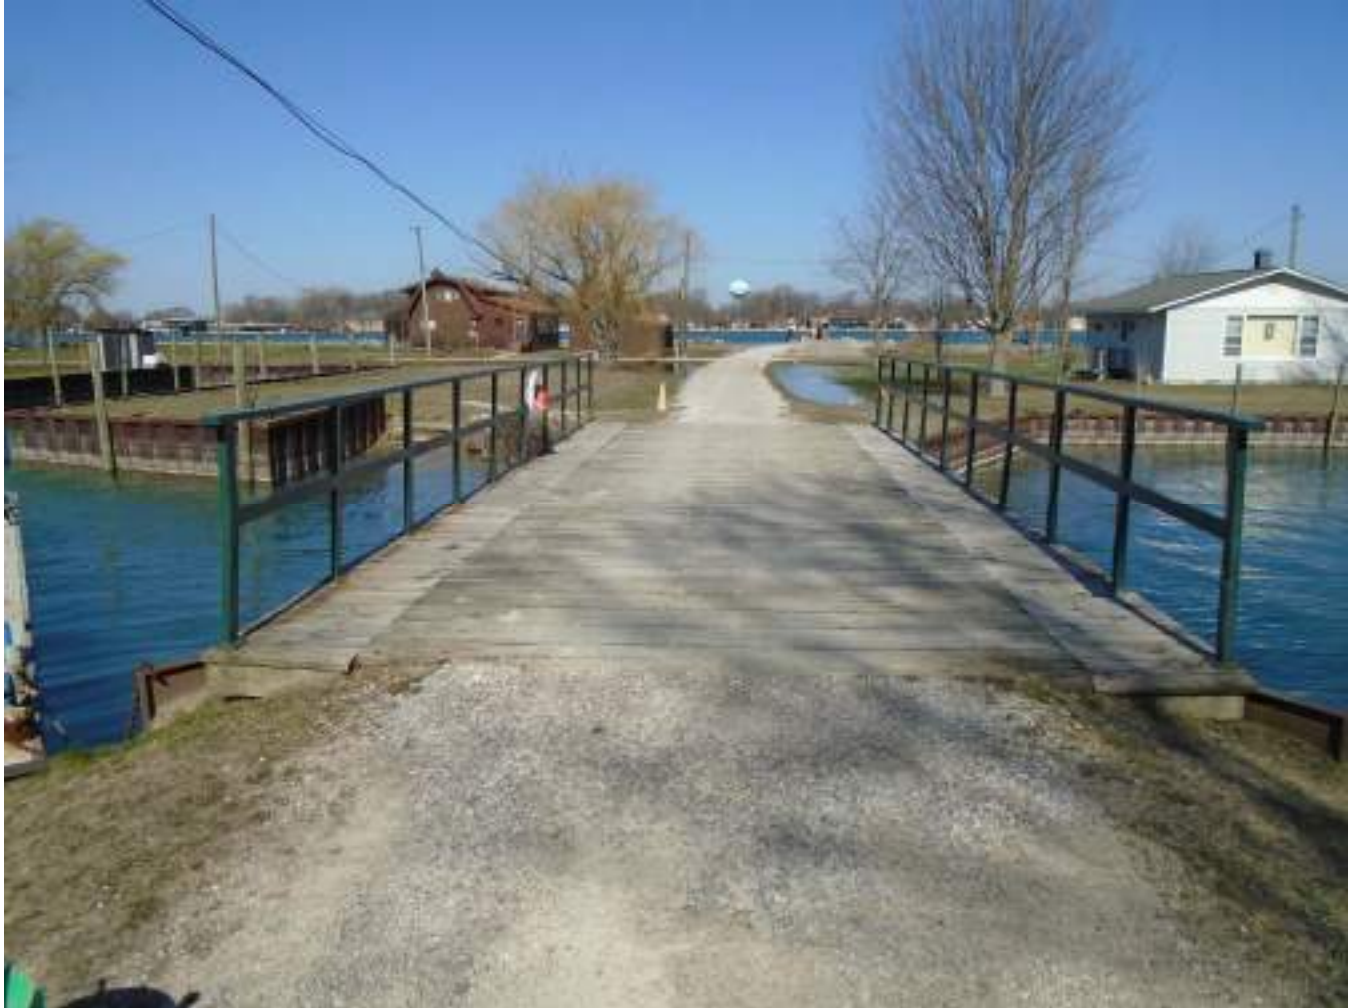
Seminole Bridge Picture #12

Looking west at east approach

General view of the steel box section railing and gravel road approach. Bridge railing is in very good condition and has a solid anchorage. The bridge railing has been recently painted. The wooden deck could use a water sealant.

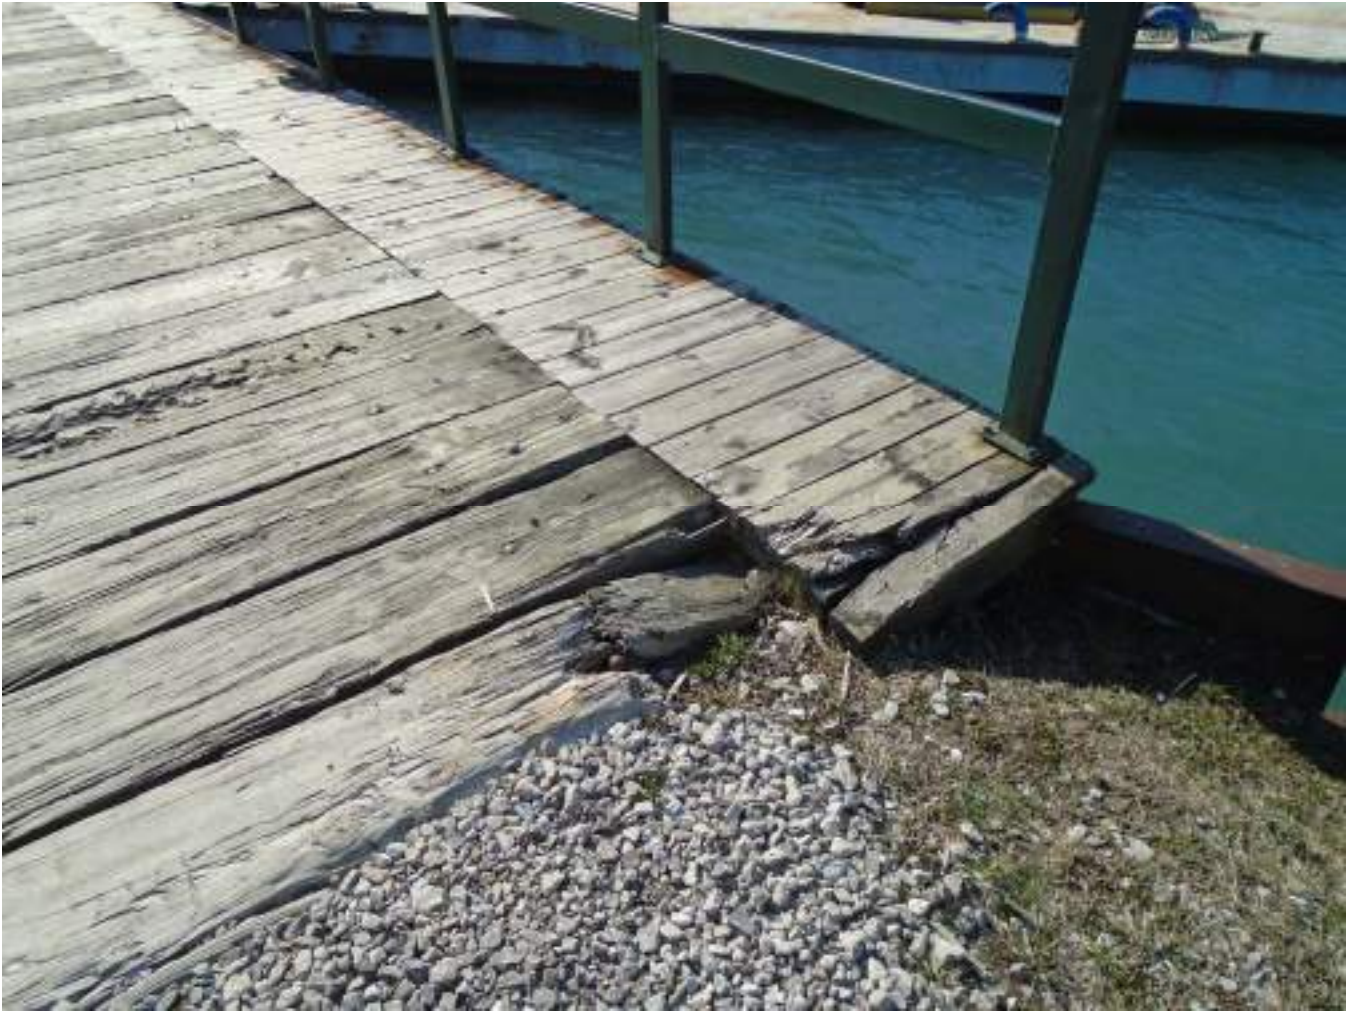
Seminole Bridge Picture #13

Rotting plank at SW corner of deck

The last 2 deck planks at both approaches are rotted and should be replaced. No other rotted planks were noted. End planks need to be replaced.

1. Place a load limit sign as follows:
 - a. 2-axle Truck Maximum Load 11 ton
 - b. 3-axle Truck Maximum Load 18 ton
 - c. 4-axle Truck Maximum Load 21 ton
 - d. 5-axle Truck Maximum Load 26 ton
 - e. 6-axle Truck Maximum Load 32 ton
2. Replace rotted deck planks at ends of deck (especially east end).
3. To keep the bridge in good shape for as long as possible, it is recommended that the steel I-beams and steel angle bracing have a coat of paint applied. Estimated cost for current highway specifications type paint job would be approximately \$40,000 to sand blast and apply a 3-coat paint system.
4. Long term (next 10 years), replace all deck planks due to advanced rotting by then.

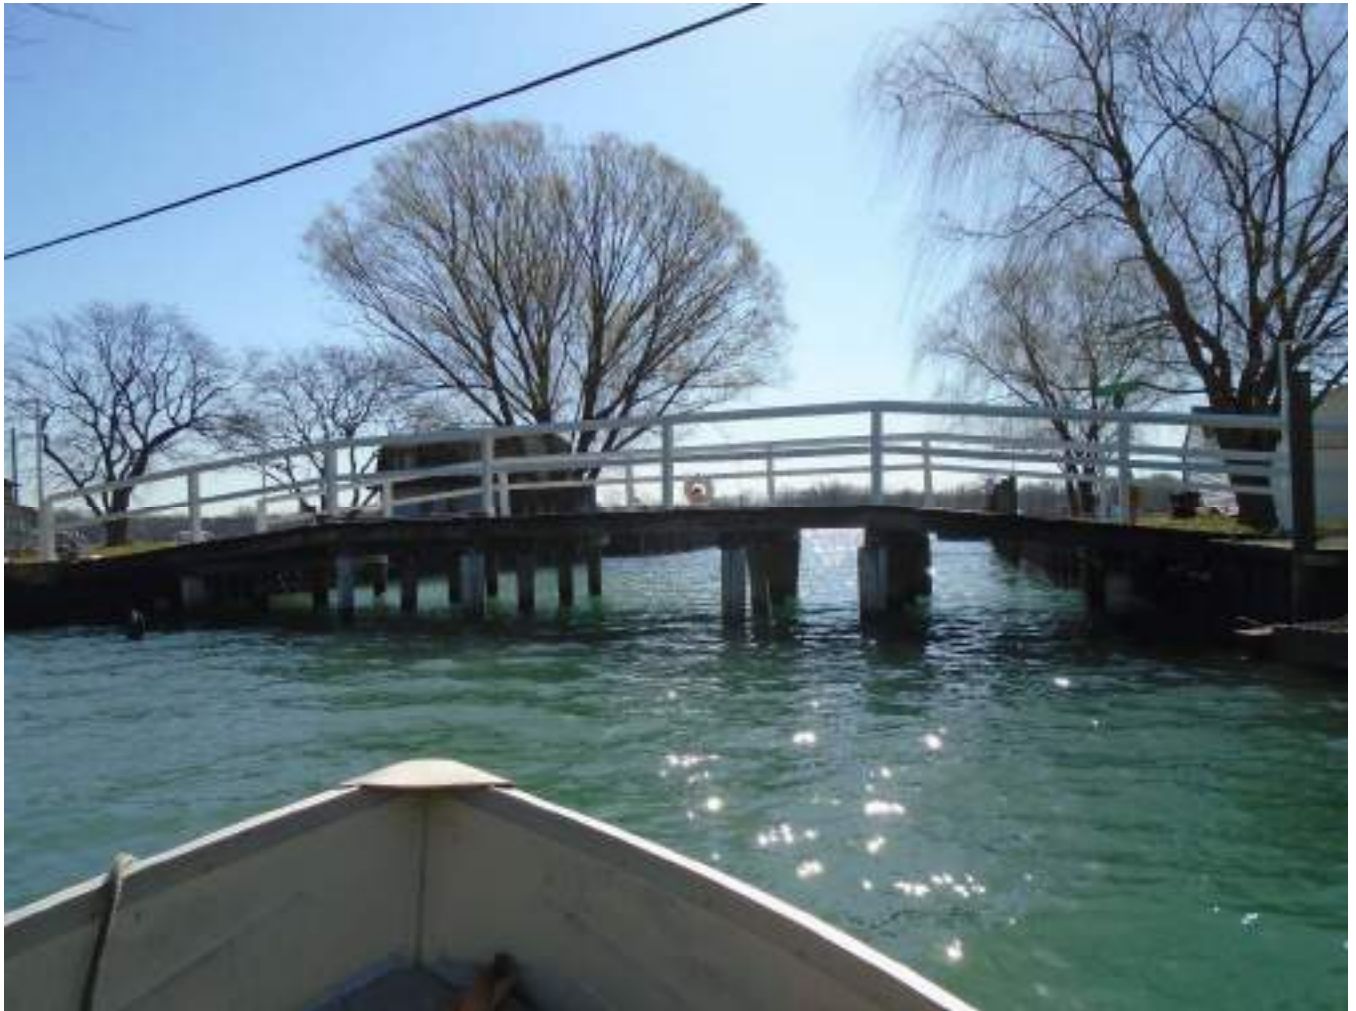
Russell Bridge Picture #1

West elevation

There are six lines of wooden piling (five shown in this view) supporting the deck sections. The bridge railing is supported by 5" by 2 1/2" wooden posts with a top rung made of 4" by 4" timbers set at a 45° angle to horizontal and the middle rung made of standard 2" by 4" studding set on edge.

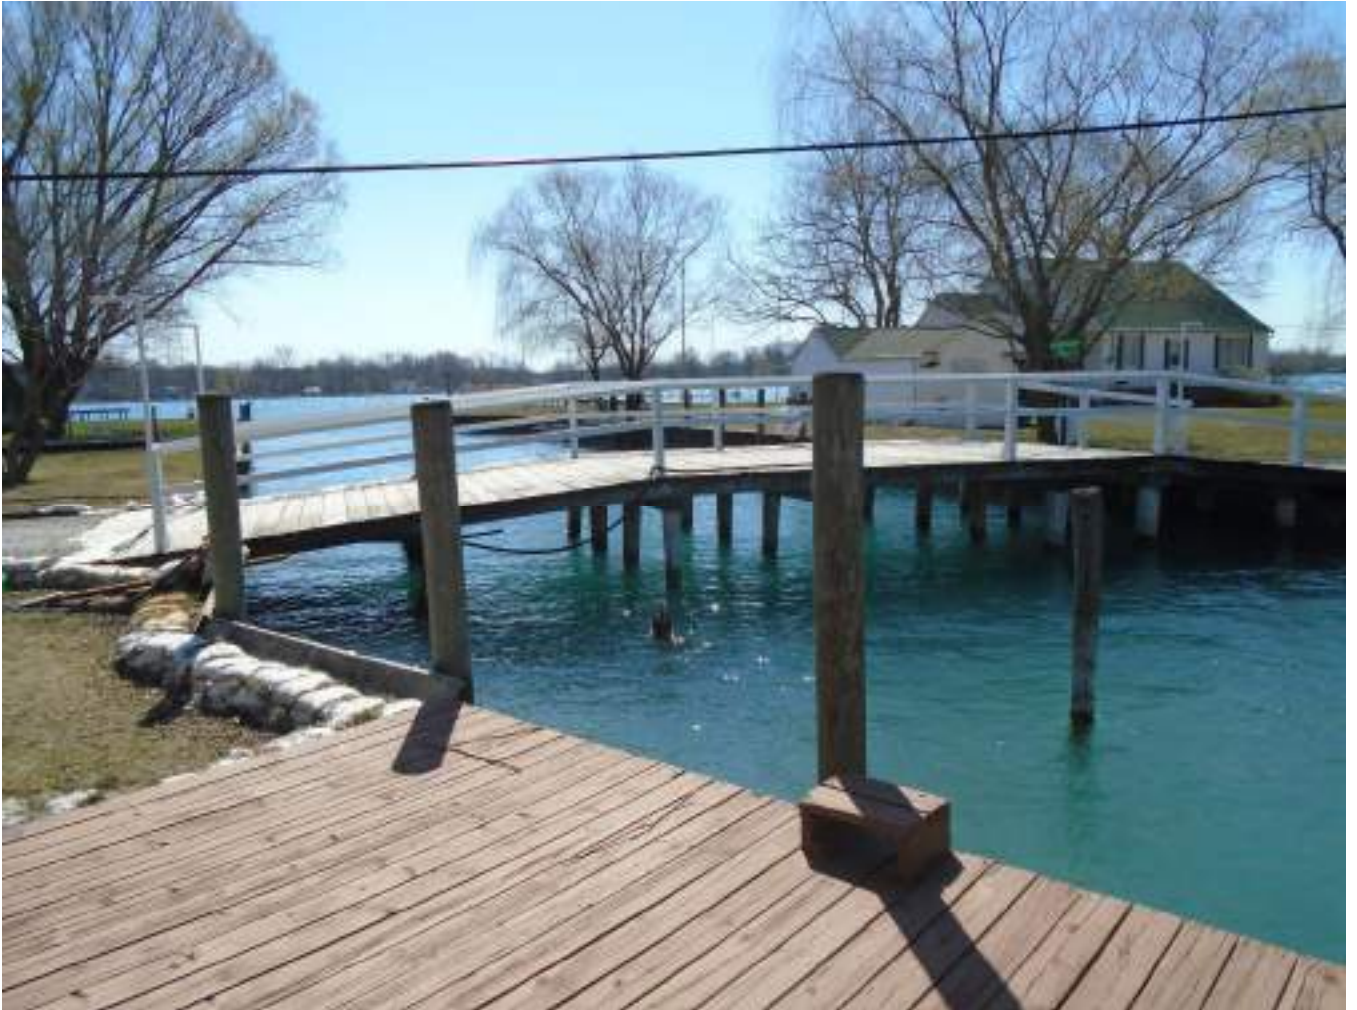
Russell Bridge Picture #2

Looking SE

Another view from the west.

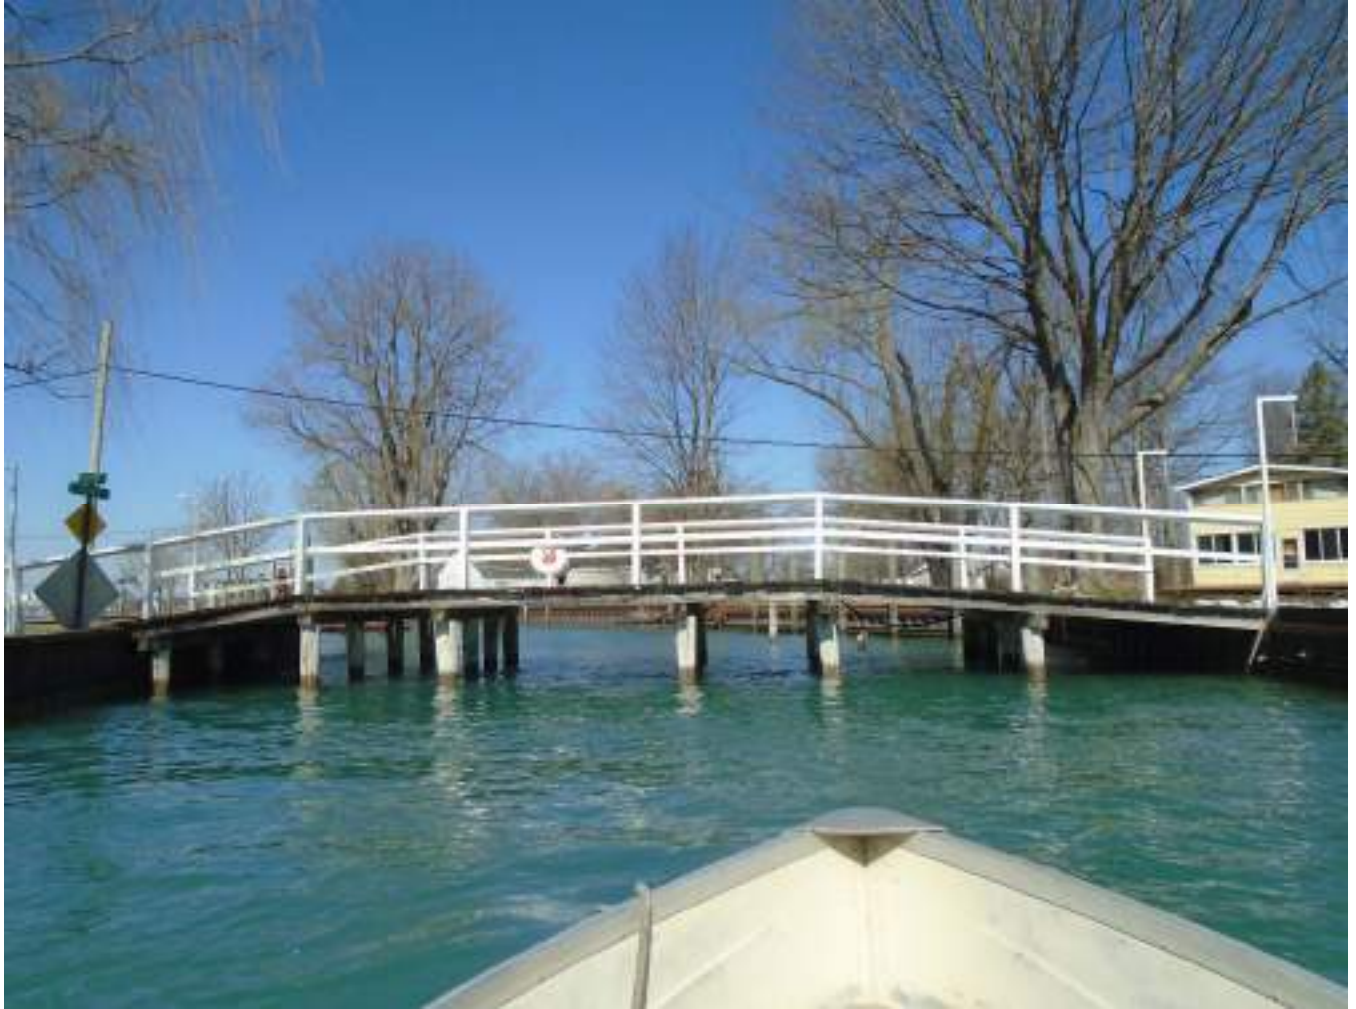
Russell Bridge Picture #3

Looking west elevation

In this view all six pile lines can be seen. Note that the farthest pile line to the south is very close to the seawall. The seawall on both ends of the bridge does not support the bridge.
