Russell Island Bridge Inspections

Inspected By: Mike Cieslinski

Inspection Date: April 12, 2023

Calculations By: Michael J. Clark, PE

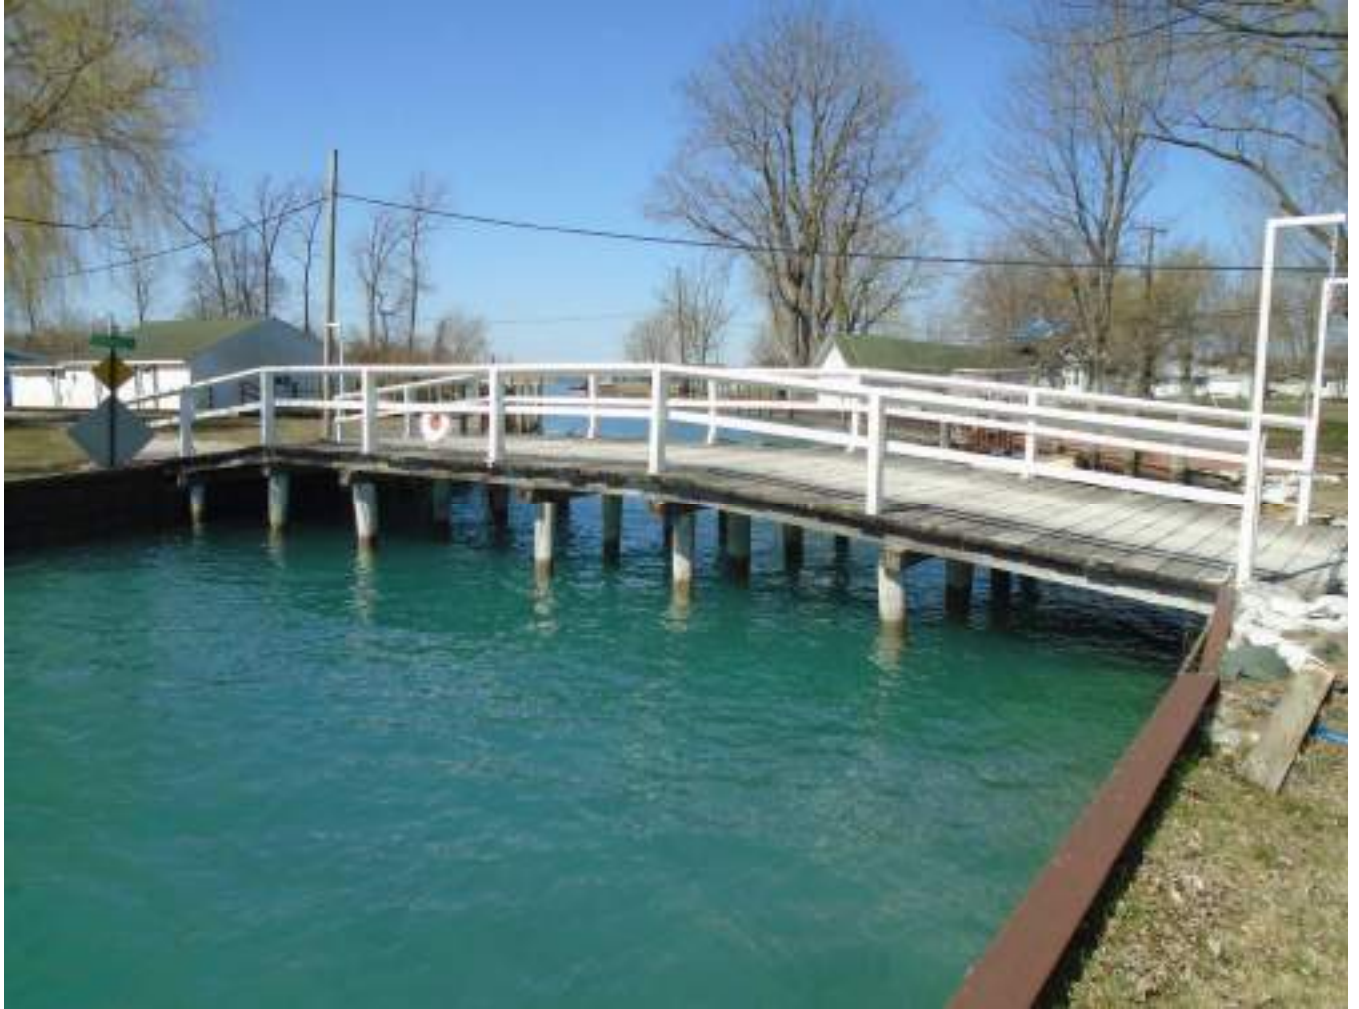
Russell Bridge Picture #4

Looking SW

Another view from the east.

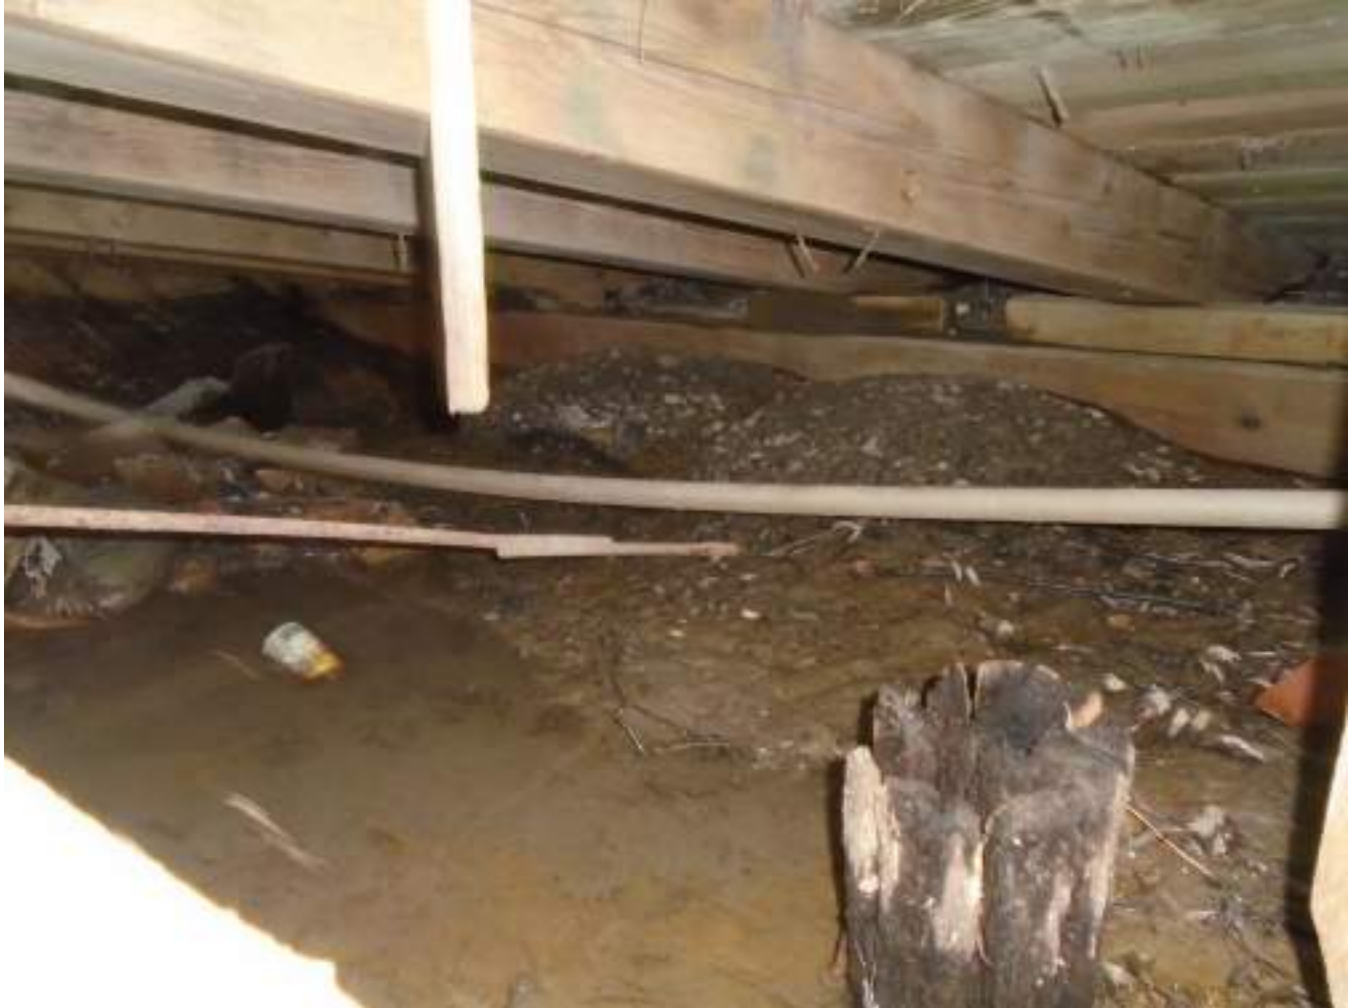
Russell Bridge Picture #5

Looking south at south bearing beam

Southern span floor beams supported by a transverse beam on bare earth.

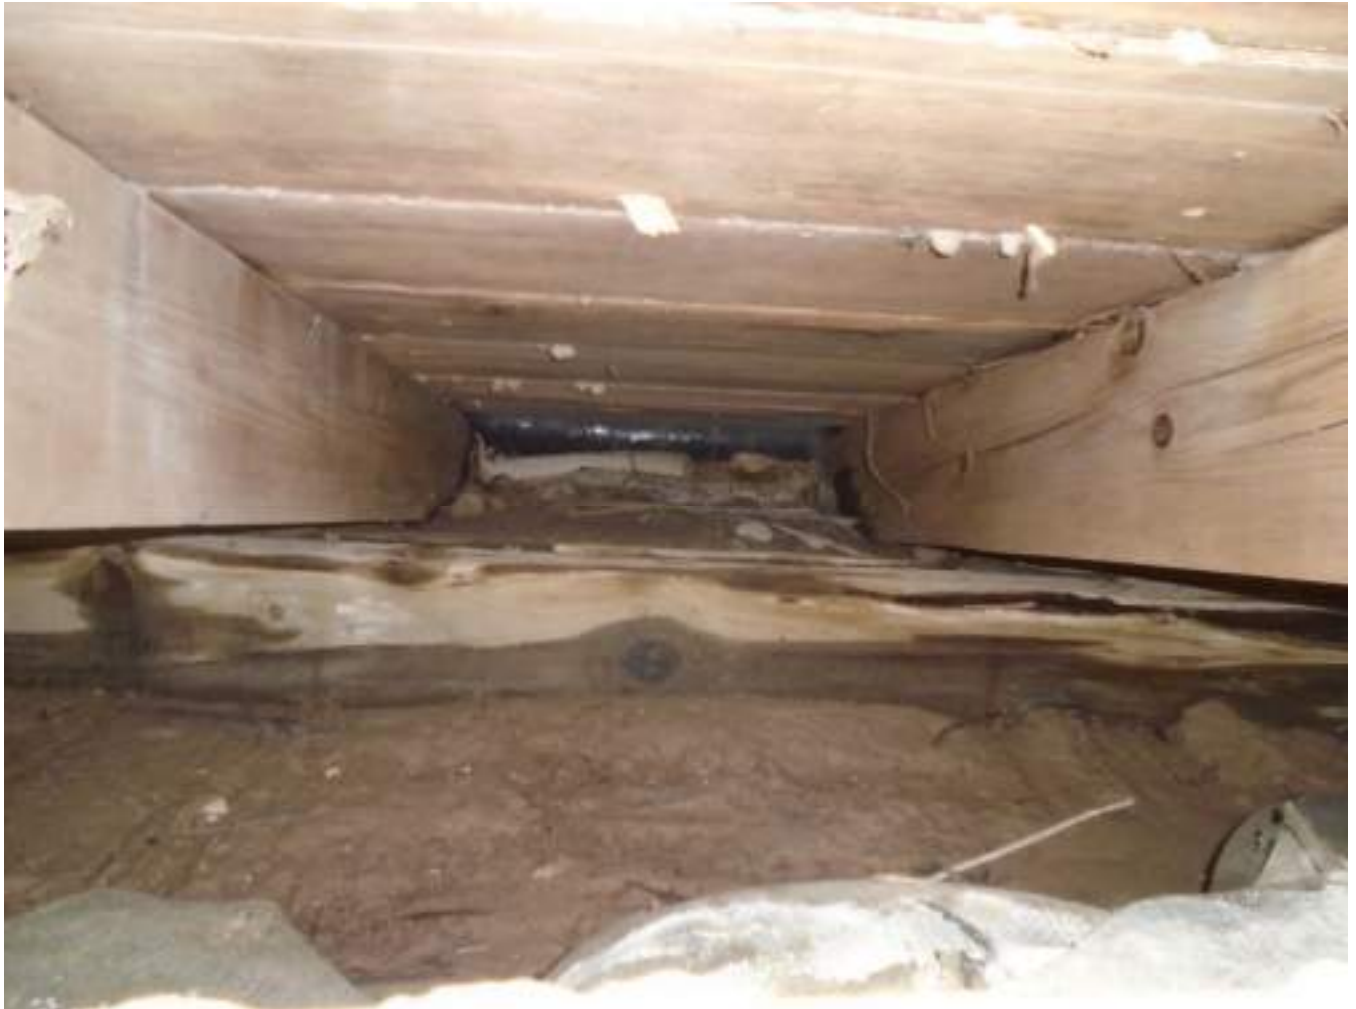
Russell Bridge Picture #6

Looking north at north bearing beam

Northern span floor beams supported by a transverse beam on bare earth.

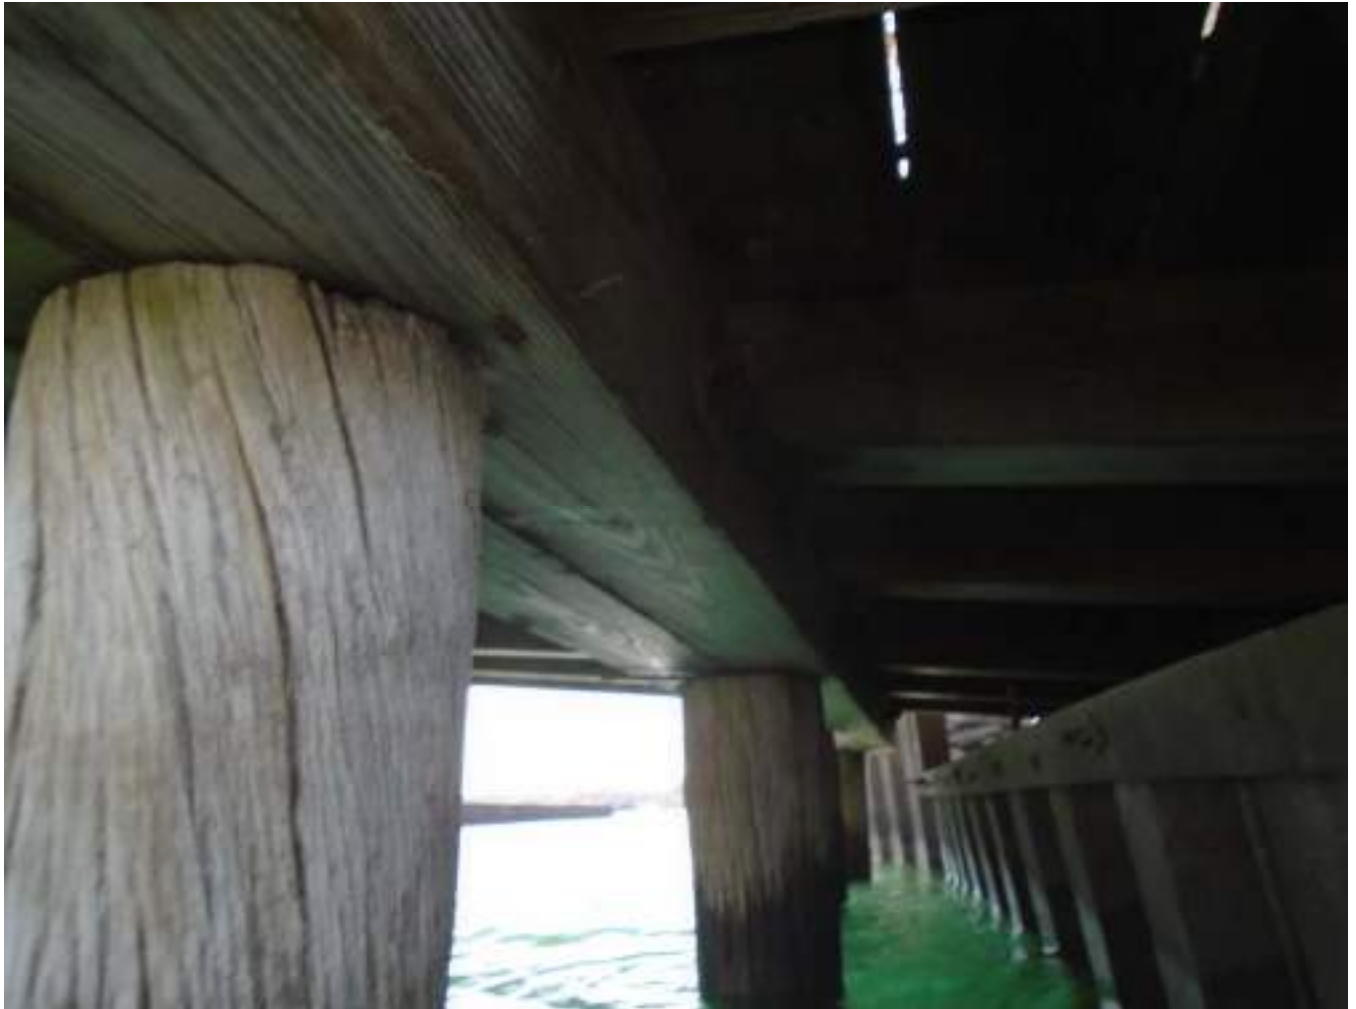
Russell Bridge Picture #7

Looking east at underside of PC1

The pile cap that is on the farthest pile line to the south (PC1) has shifted approximately 3/4 the pile diameter south (no change from the previous inspection). Since the last inspection, an additional 7 ½" by 7 ½" pile cap has been added to the most southerly pile line and secured to the existing pile cap.

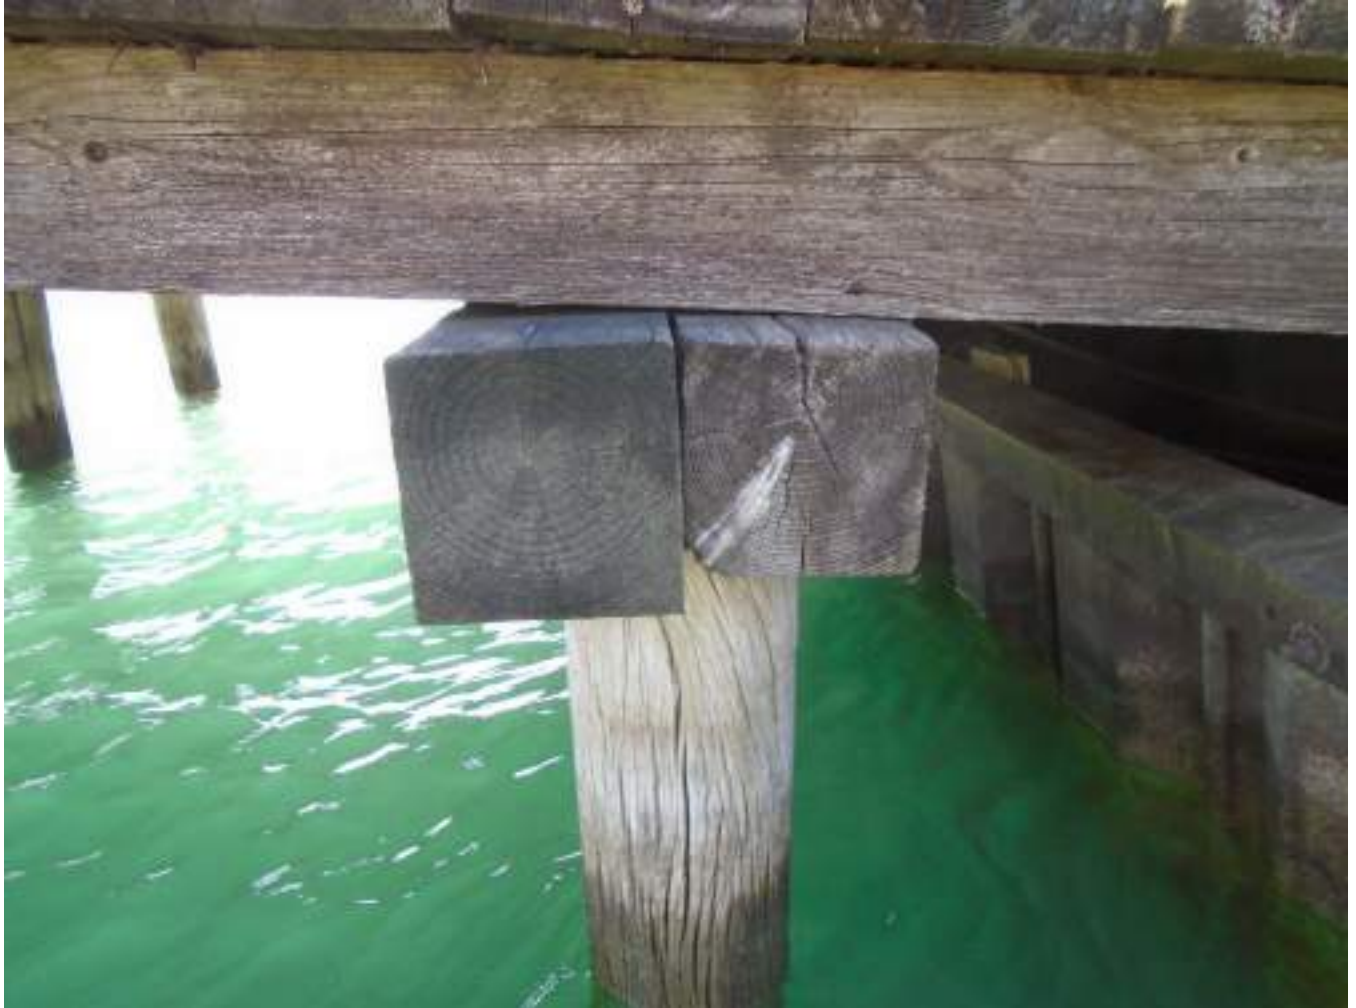
Russell Bridge Picture #8

Looking east at PC1/P1 with no contact of FB to PC1 repair

However, the floor beams are not in contact with this pile cap “widening.” The gaps are approximately ½” tapering down to ¼” (typical of all floor beams at PC1).

4. An additional 7 ½" by 7 ½" pile cap has been added to the most southerly pile line and secured to the existing pile cap. However, the floor beams are not in contact with this pile cap "widening." It is recommended that shims be installed so that all pile caps are in full contact with their associated piles.

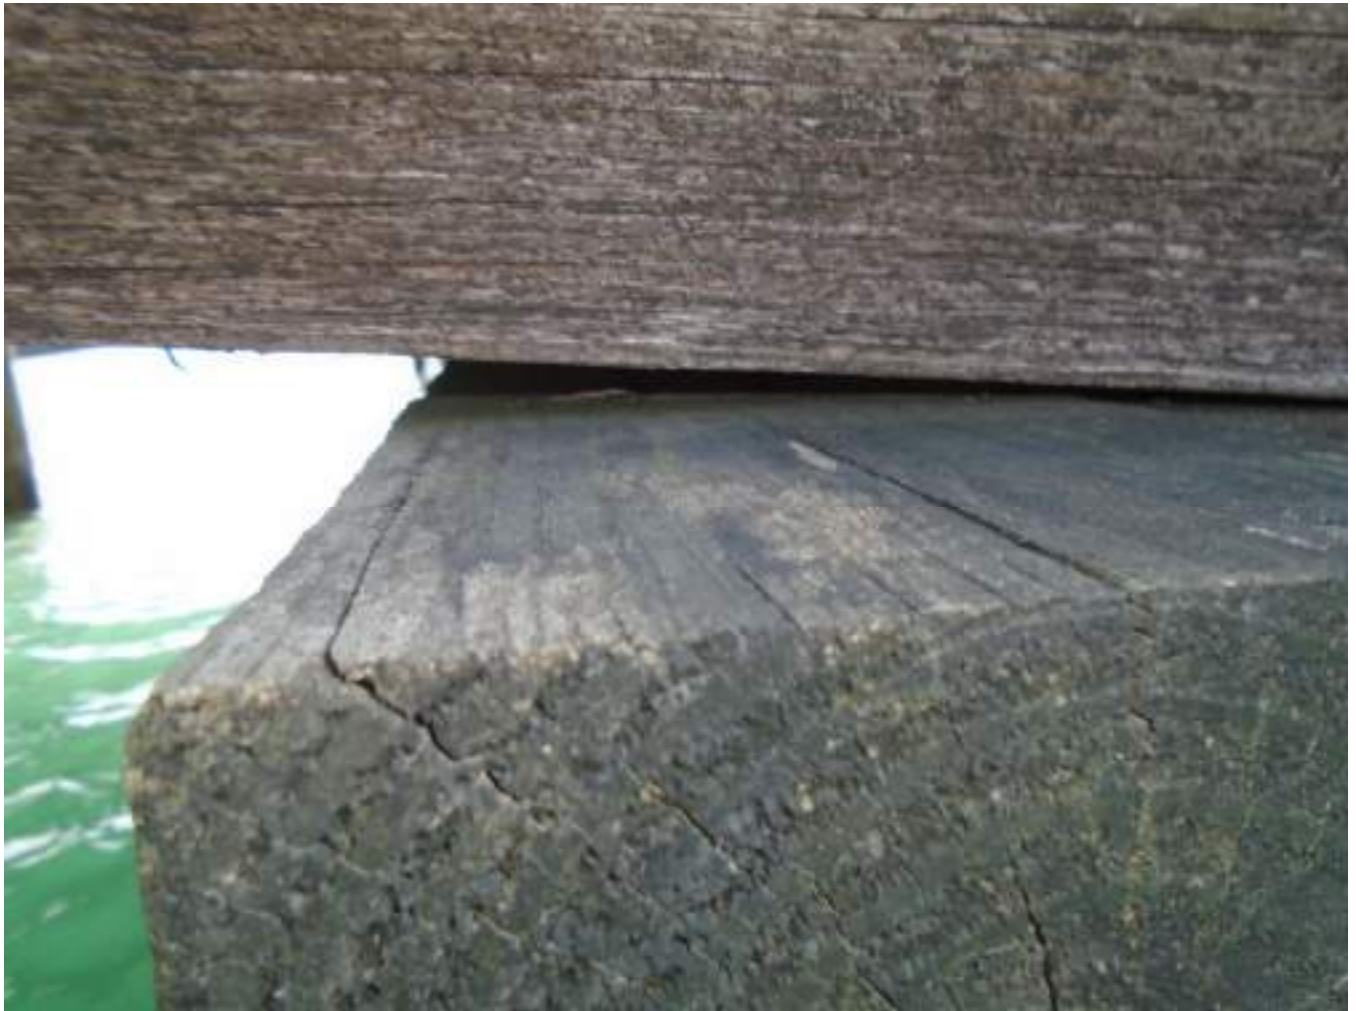
Russell Bridge Picture #9

Close-up looking east at PC1/P1 with no contact of FB to PC1 repair

Close-up of the gap between this additional pile cap and existing floor beam.

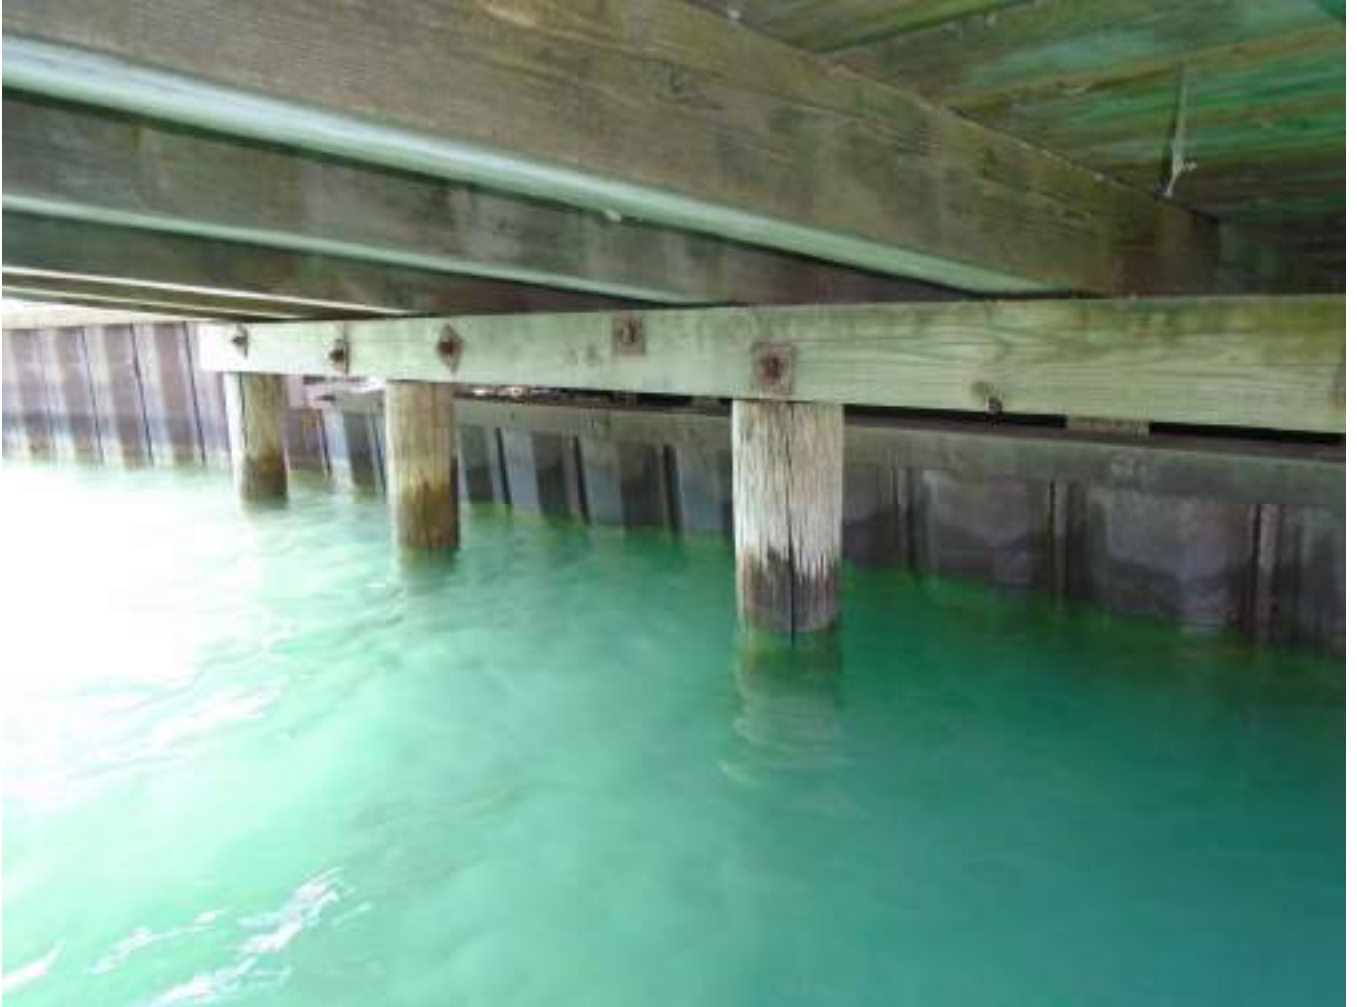
Russell Bridge Picture #10

Looking SE at PC1

Added pile cap secured to existing pile cap. Note that the 5 floor beams visible have gaps.

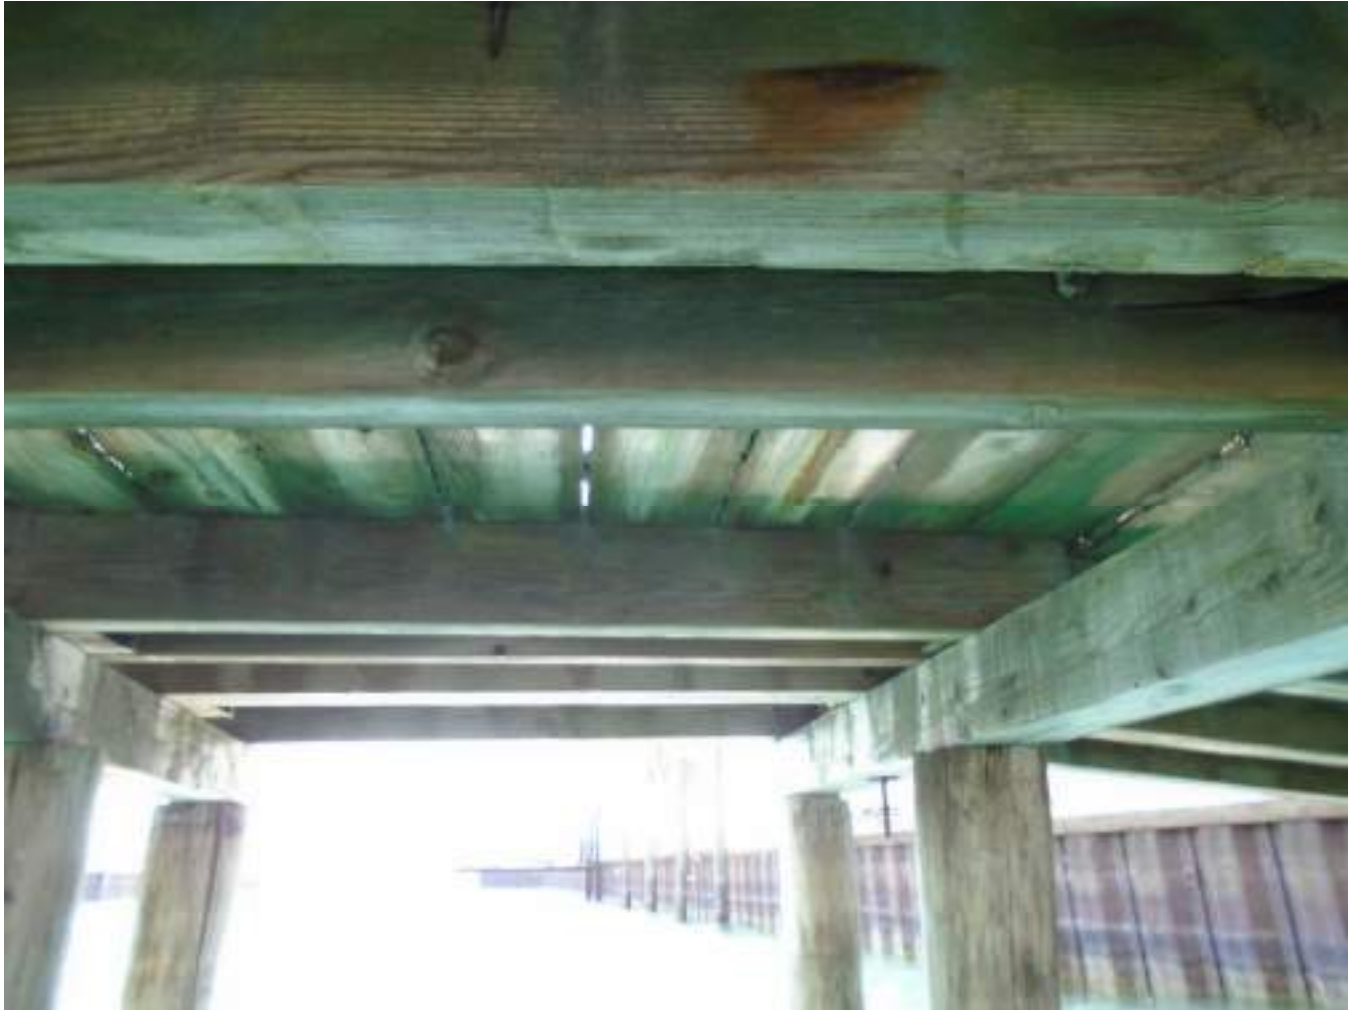
Russell Bridge Picture #11

Span 3 looking east between FB3 & FB4

Two beams appear to have had repair work done with the 7 ½" by 7 ½" beam missing and replaced with two 7 ½" by 4" timbers attached to either side of the adjacent square beam as shown (See detailed drawing for exact location). No change from previous inspection.

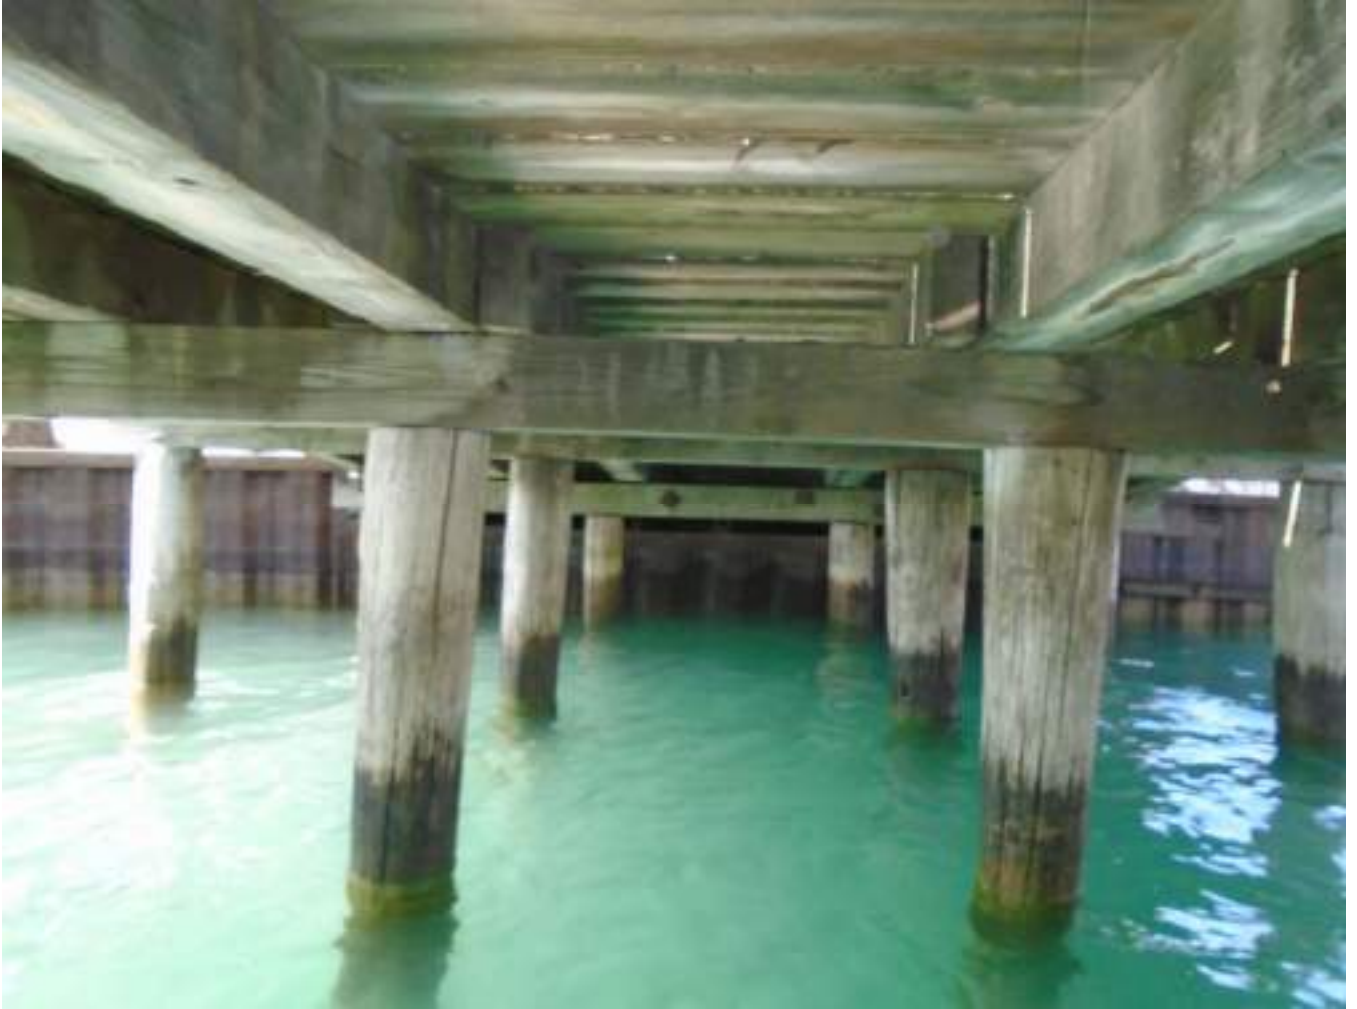
Russell Bridge Picture #12

Looking south at PC3

Typical view of floor beams. The beam are mainly 7 ½” by 7 ½” square timbers spaced anywhere from 2’-3” to 4’-3” apart.

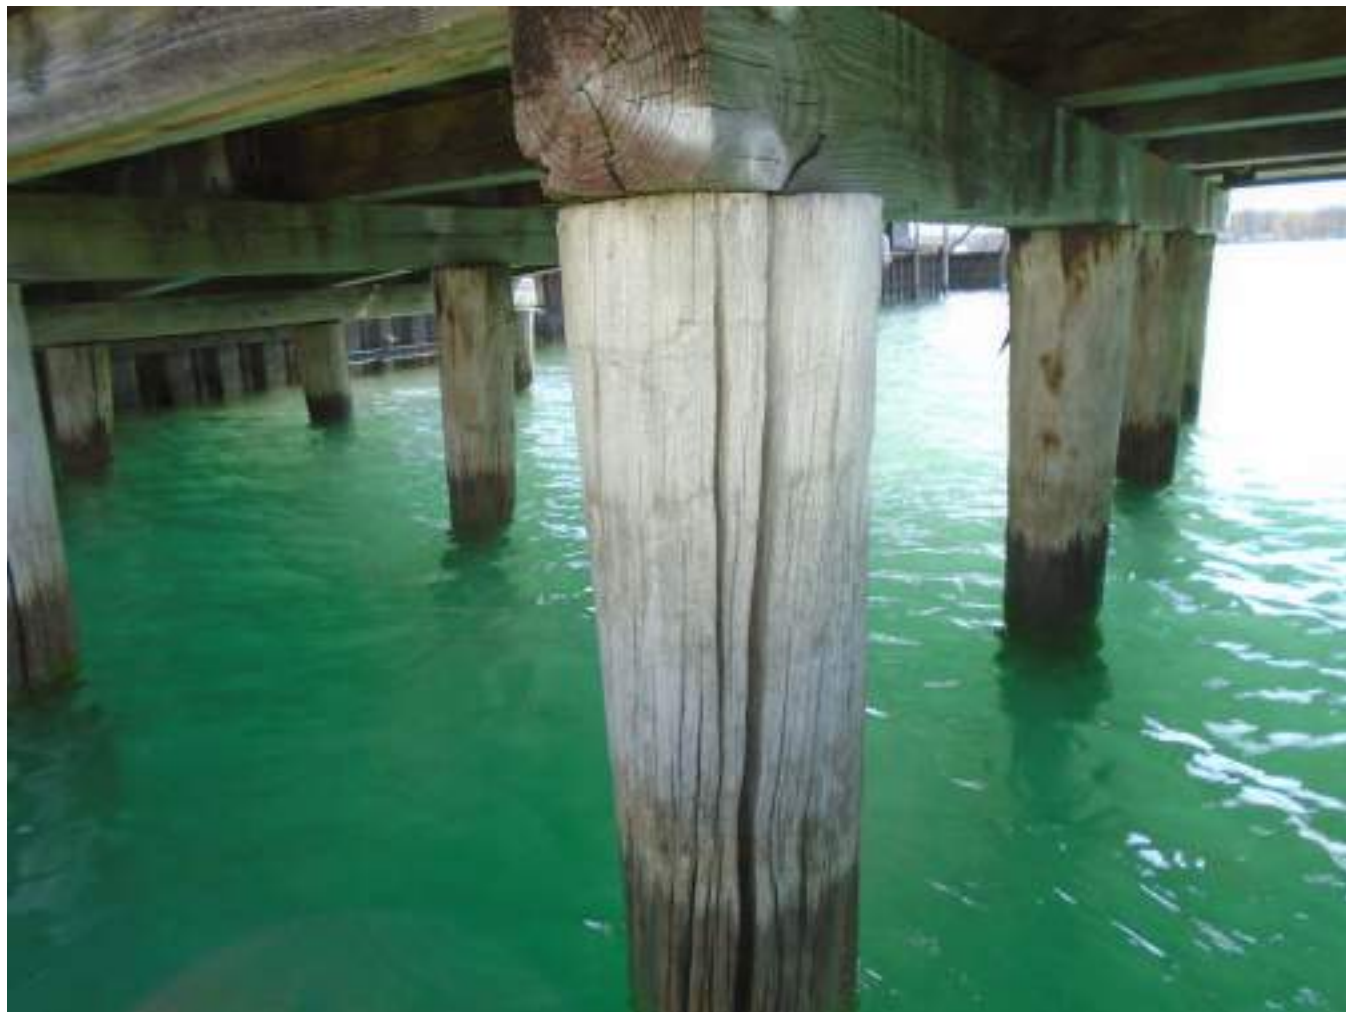
Russell Bridge Picture #13

Looking east at PC4/P1

Shows typical checks and splits of the wood piles.

6. Most of the piles have checks and splits. It is recommended that banding be installed around all piles to mitigate the propagation of these checks and splits.

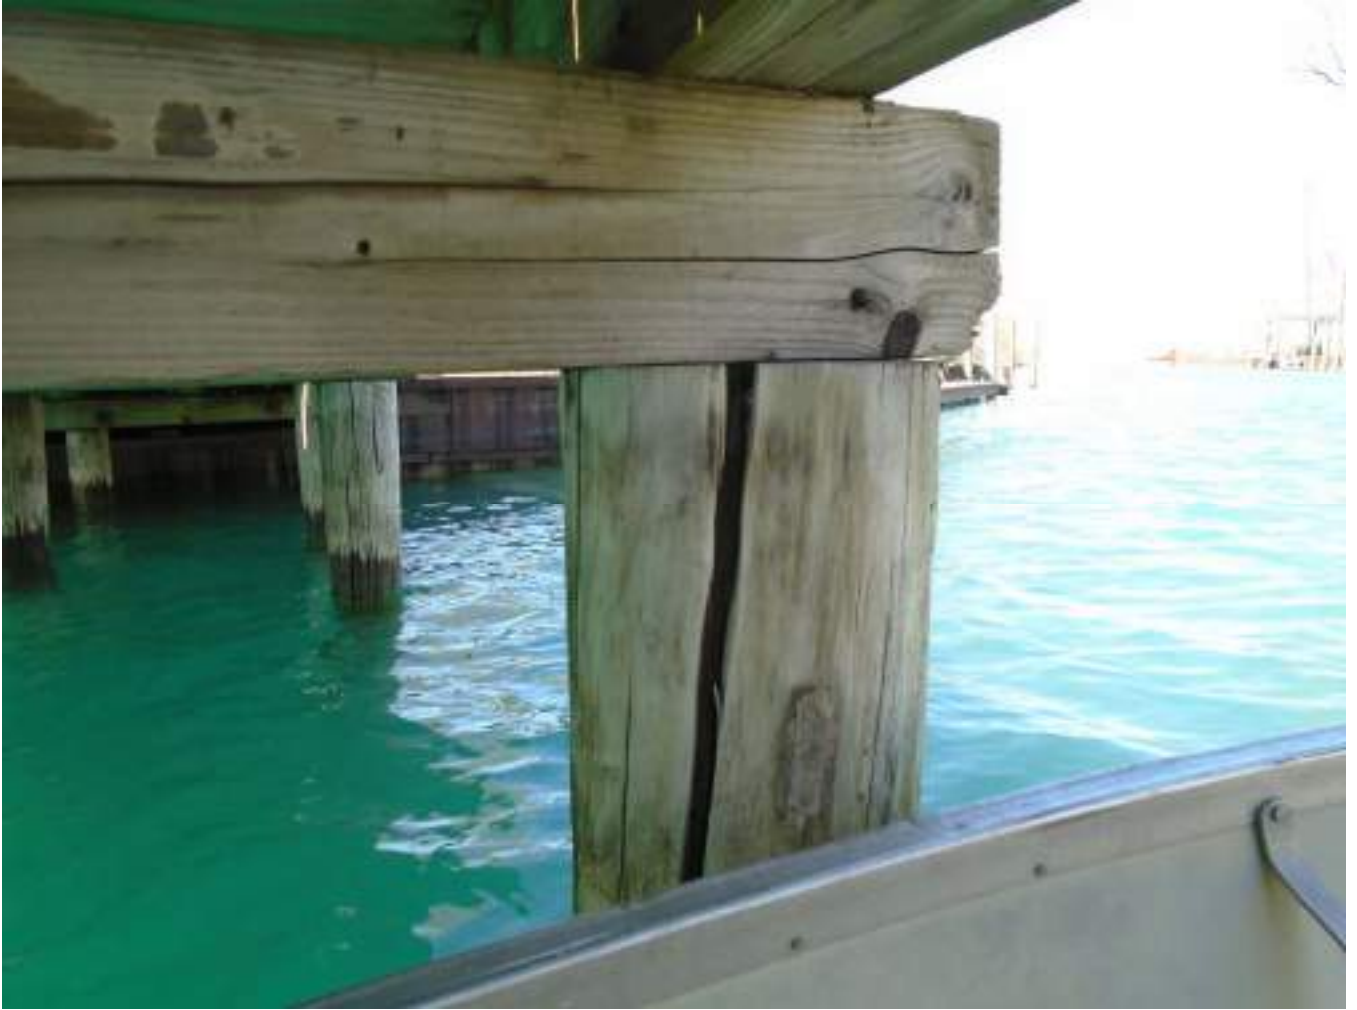
Russell Bridge Picture #14

Looking SW at PC4/P1

Shows typical checks and splits of the wood piles. Flip side of Picture #13.

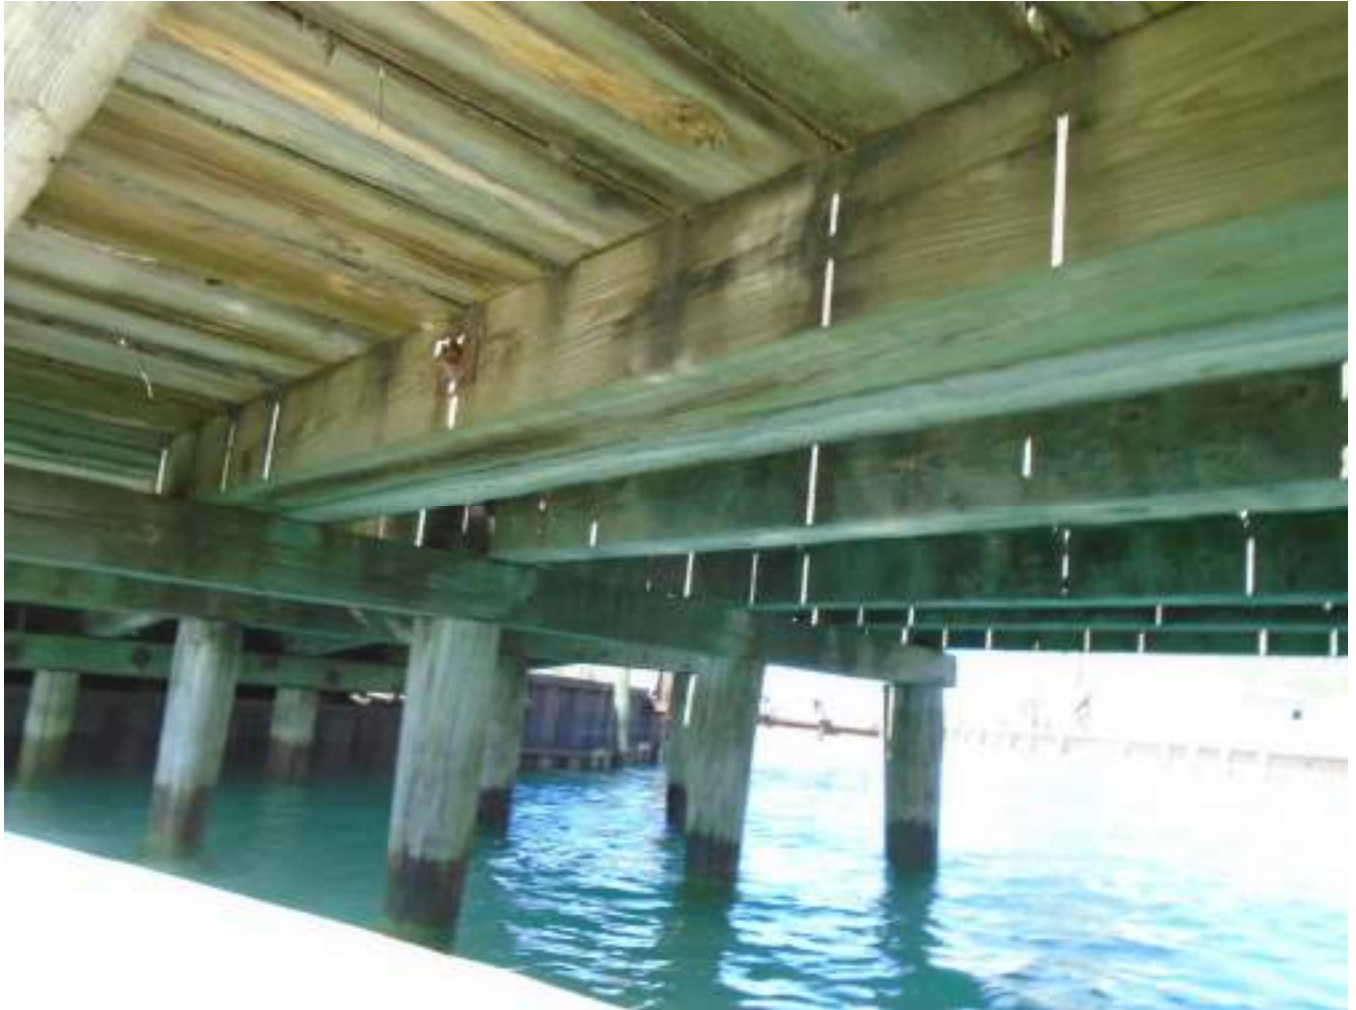
Russell Bridge Picture #15

Looking SW at PC3/FB5 repaired floor beam stack

Since the last inspection, the stack of planking has been replaced with two, 7 1/2" by 7 1/2" square timbers secured together (see bridge plans for location).

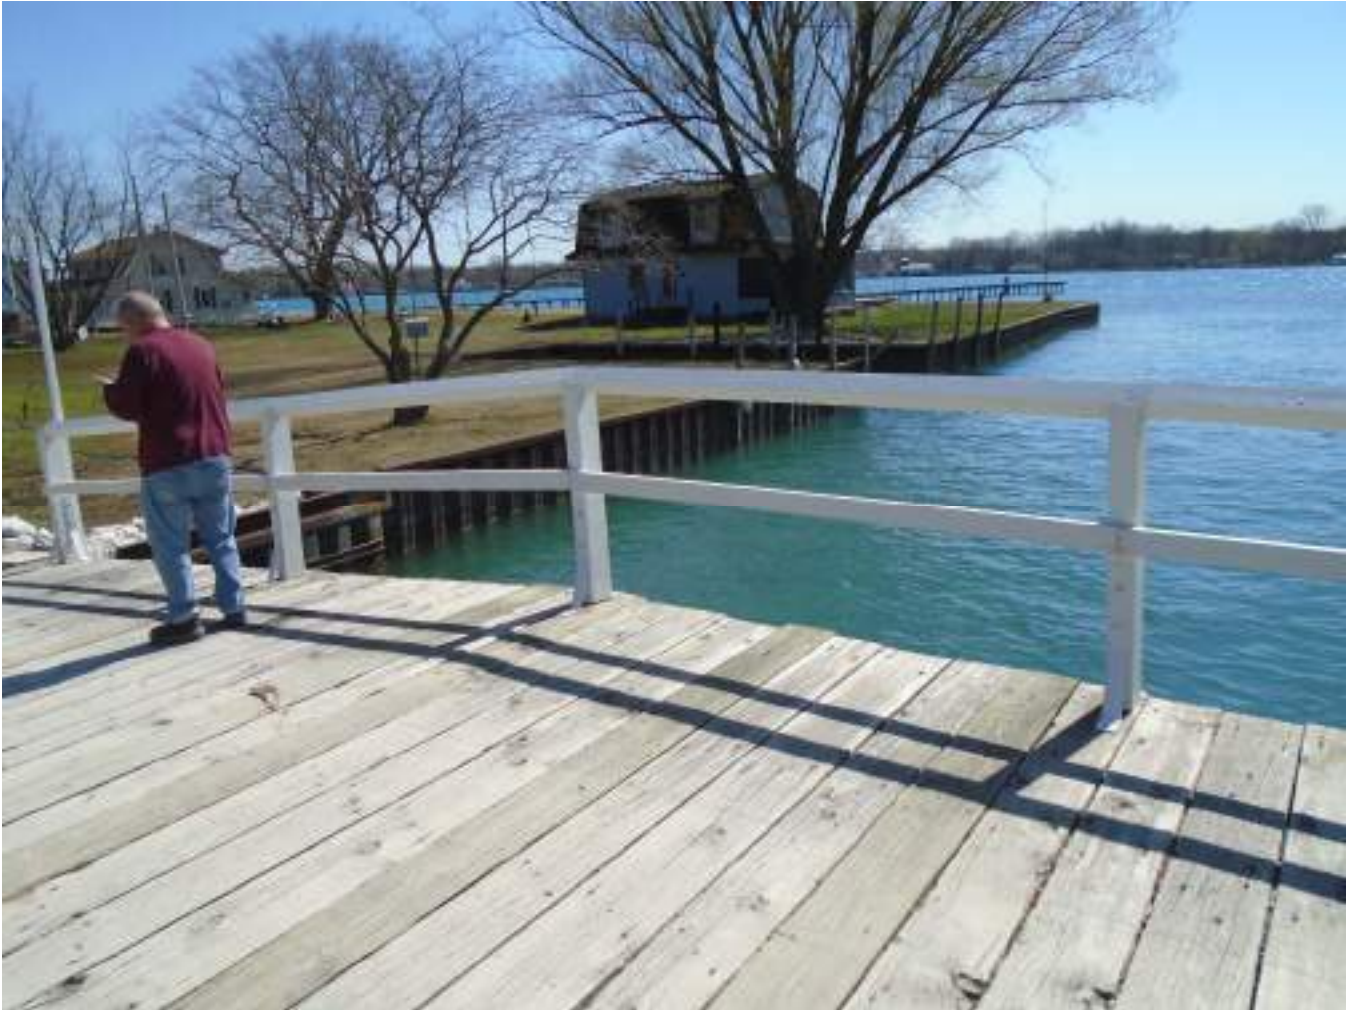
Russell Bridge Picture #16

Looking NE at railing and deck

A good view of the bridge railing attachment of post to deck, steel brackets are lag screwed to post and deck to hold things together. The posts sit on top of the deck. The railing is in very good condition.

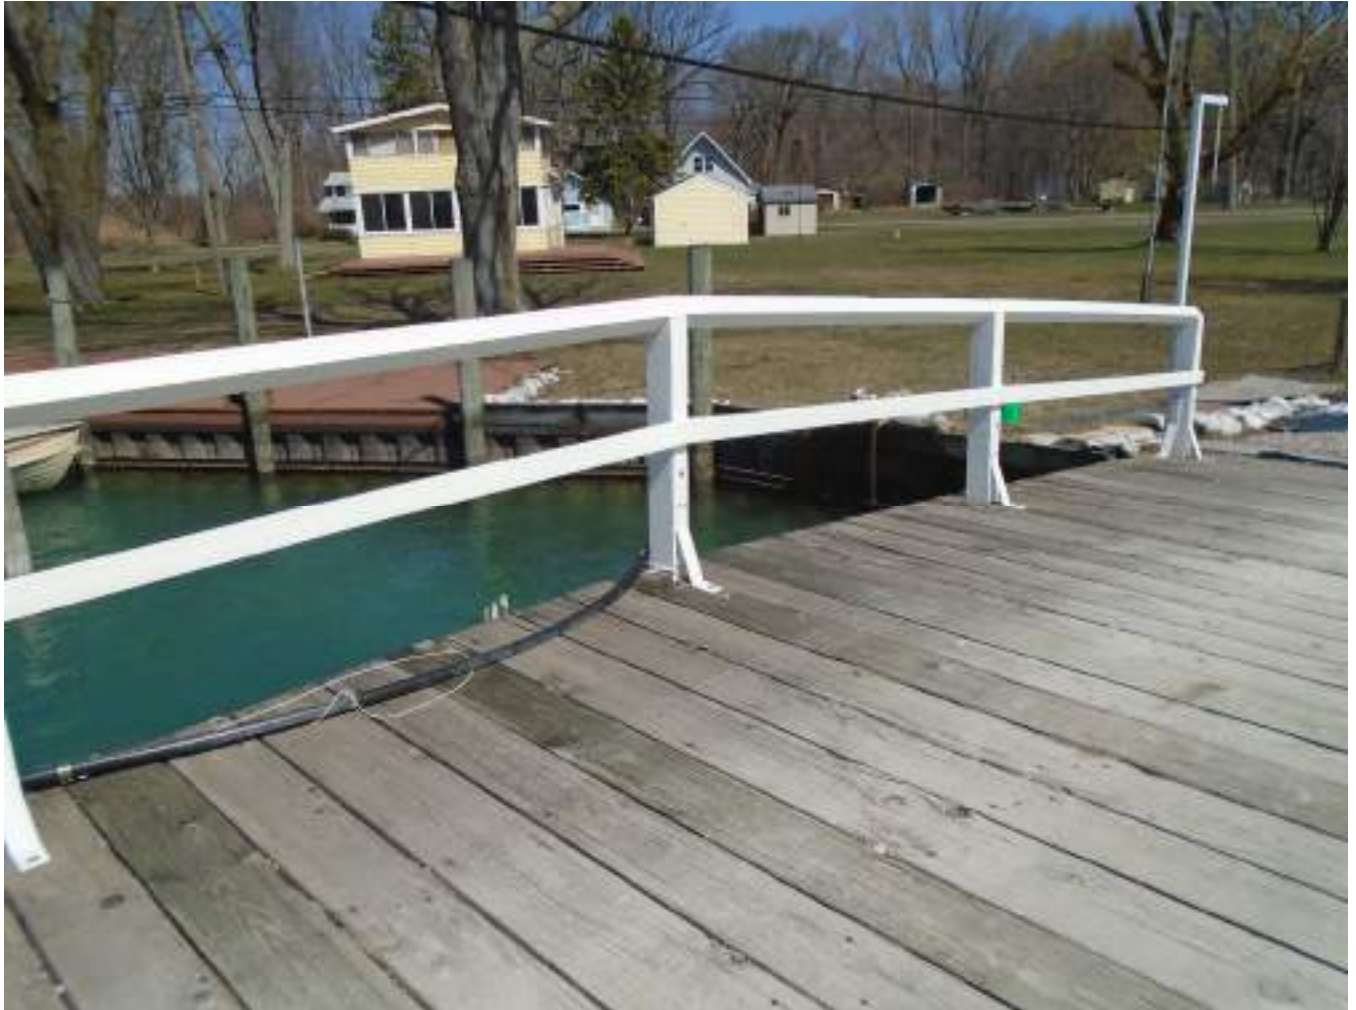
Russell Bridge Picture #17

Looking NW at railing and deck

The bridge railing is supported by 5" by 2 ½" wooden posts with a top rung made of 4" by 4" timbers set at a 45° angle to horizontal and the middle rung made of standard 2" by 4" studding set on edge.

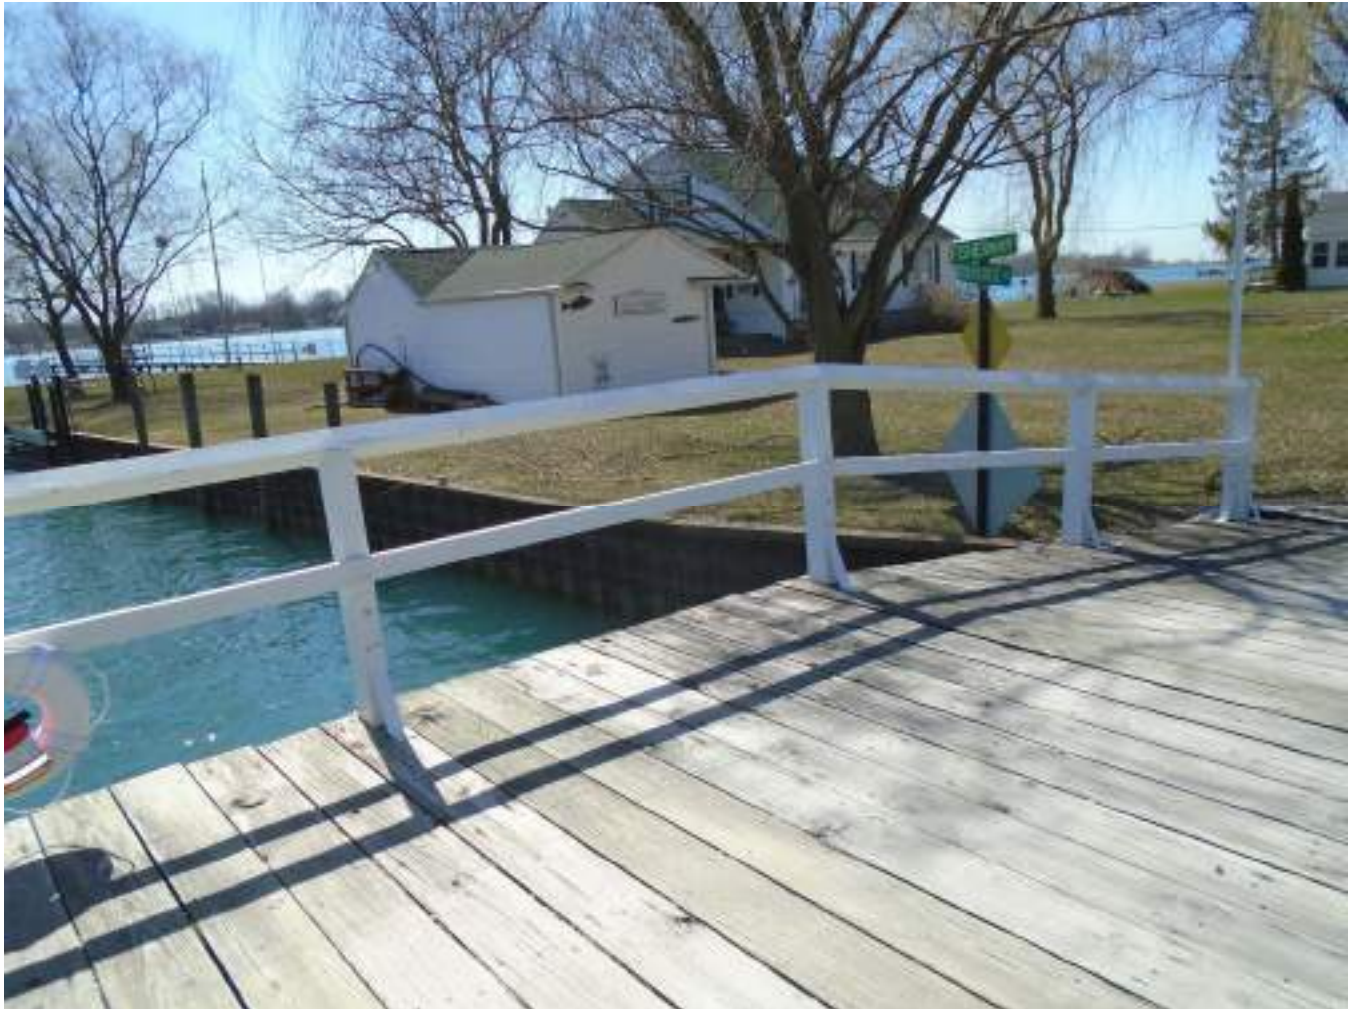
Russell Bridge Picture #18

Looking SE at railing and deck

A view of the bridge railing and deck planks.

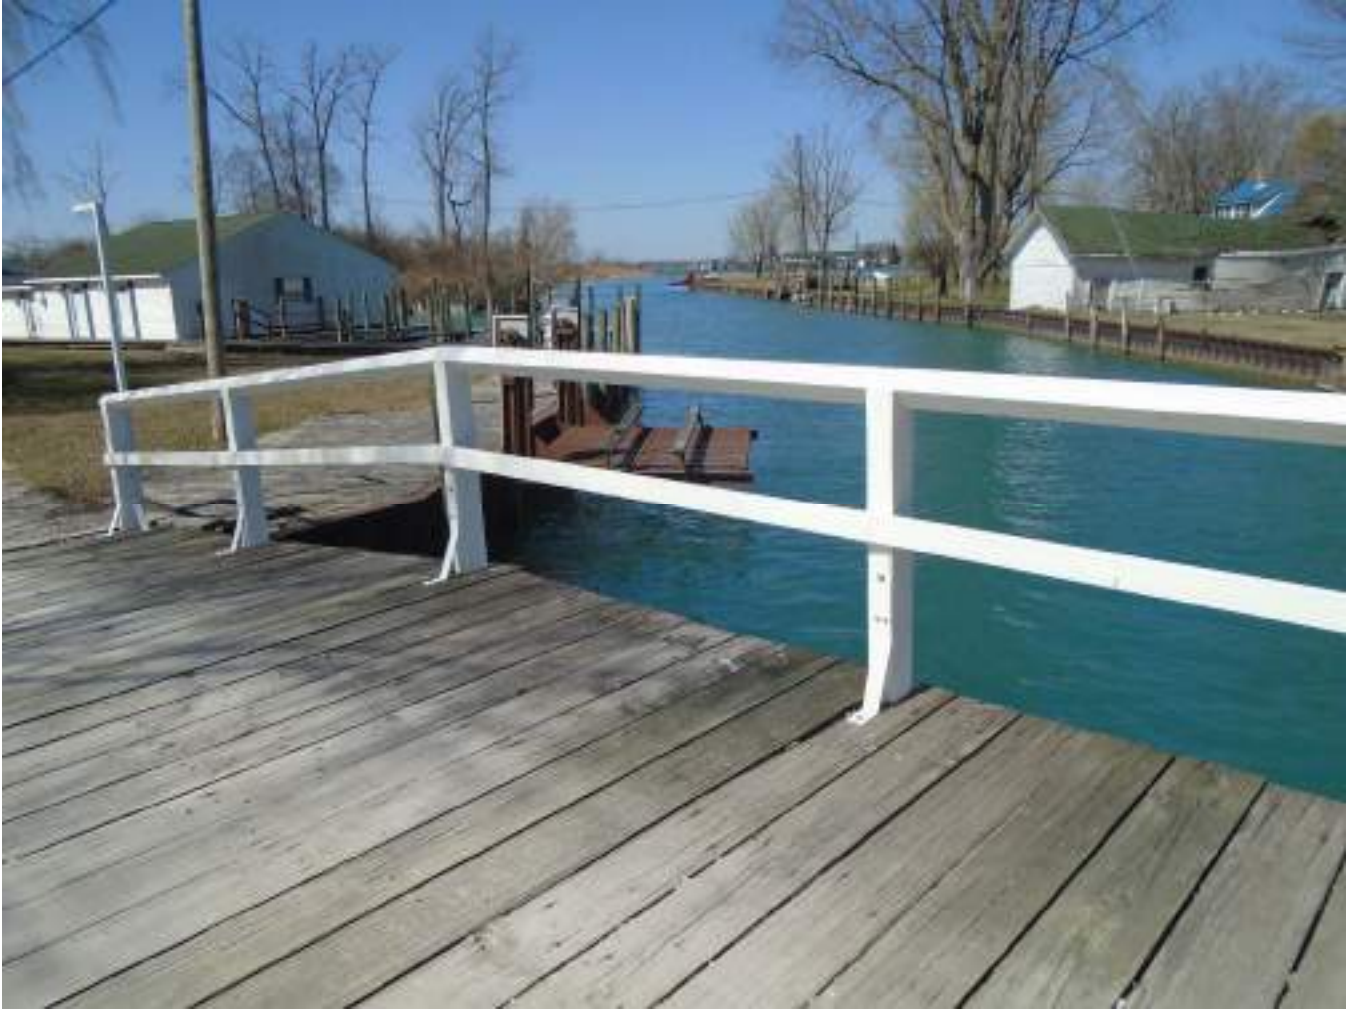
Russell Bridge Picture #19

Looking SW at railing and deck

Another view of the bridge railing and deck planks.
