Russell Island Bridge Inspections

Inspected By: Mike Cieslinski

Inspection Date: April 12, 2023

Calculations By: Michael J. Clark, PE

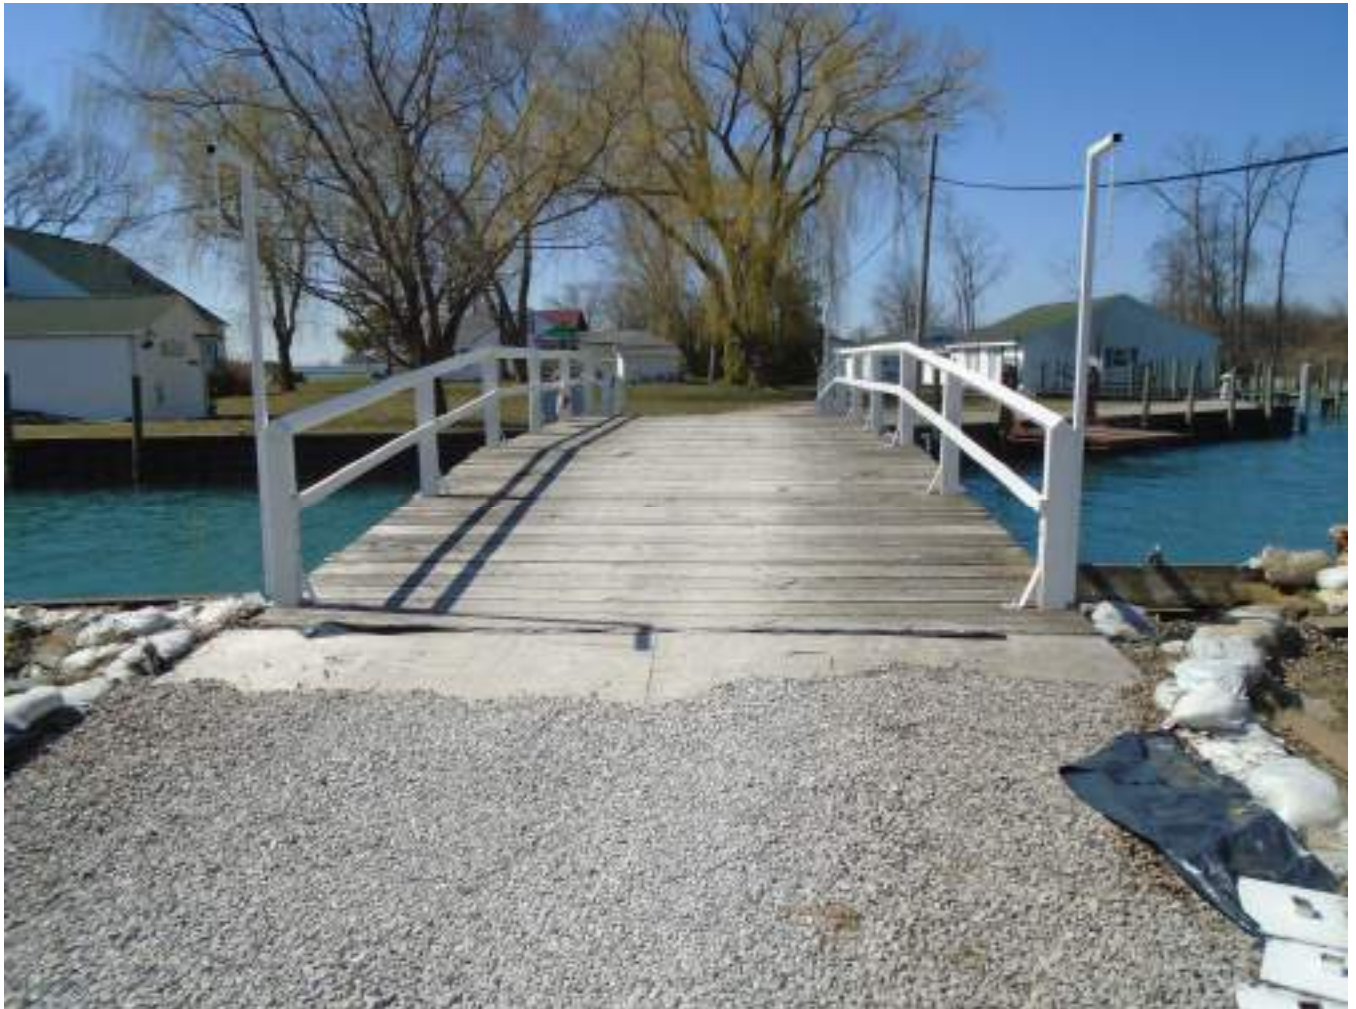
Russell Bridge Picture #20

Looking south from north approach

8-foot gravel road approach in very good condition. The steel seawall around bridge is in very good condition. The deck is composed of 2 ½" by 9" planking set with wide dimension horizontal. Planks are in generally very good condition with some minor wear along center from golf cart tires. Since the previous inspection, loose planks have been secured and rotted planks have been replaced.
